B24 Liberator A72-80 Underwater Dive Inspection Truscott WA Discovered 17-18 Aug 2009

B-24 Liberator

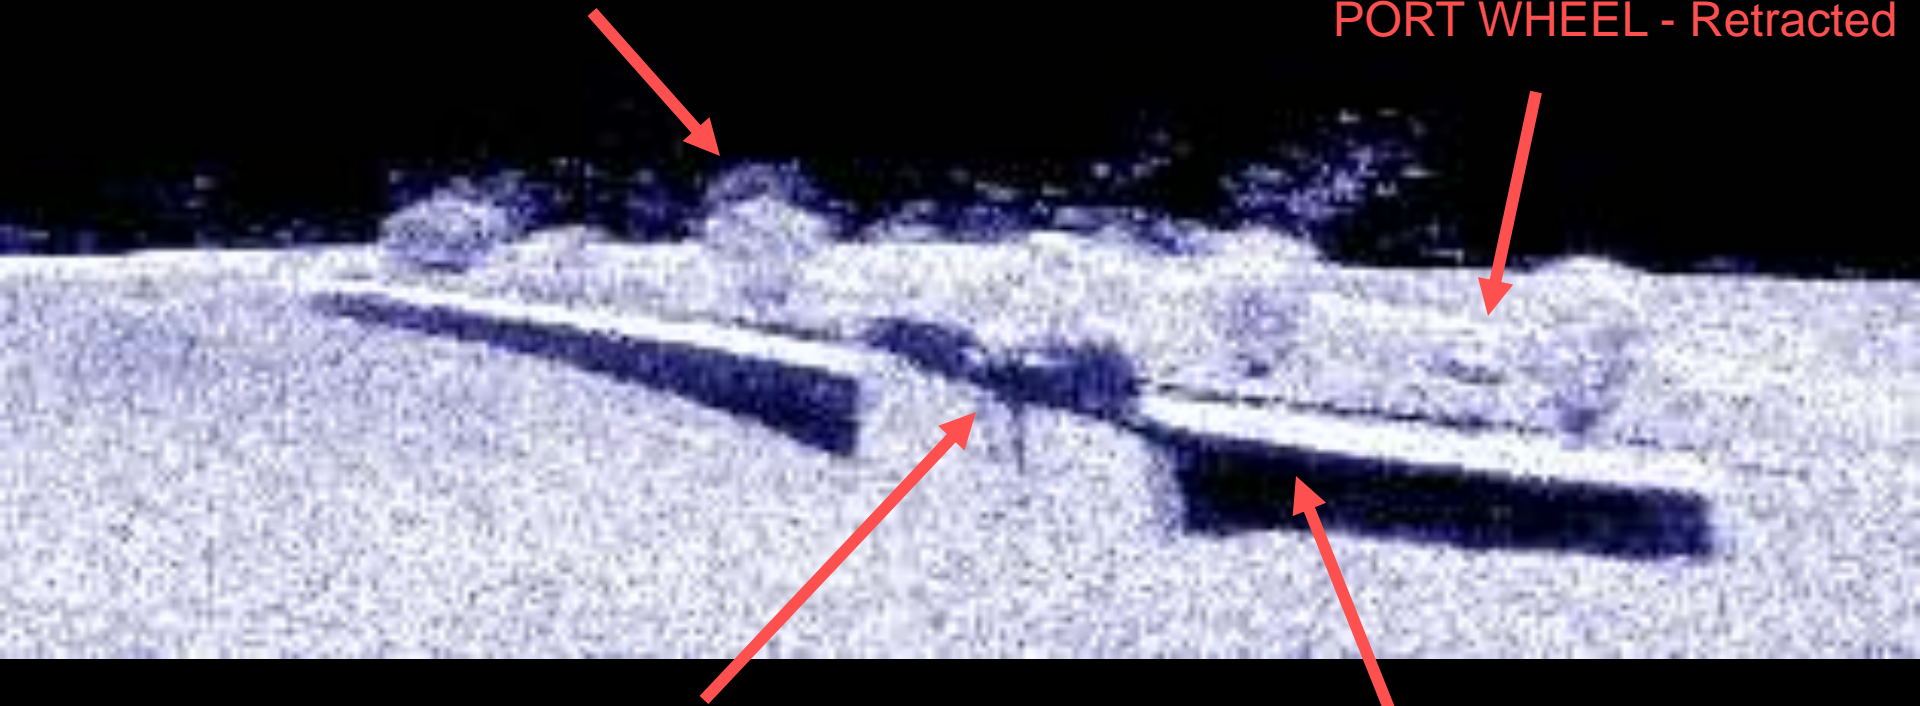
SIDE SCAN IMAGERY – WING (Inverted)

ENGINES – All propellers absent.
Probably destroyed on impact due
to high power settings applied in
an attempt to maintain height.

PORT WHEEL - Retracted

FUSELAGE – Badly damaged.
Mostly absent.

FLAPS - Lowered

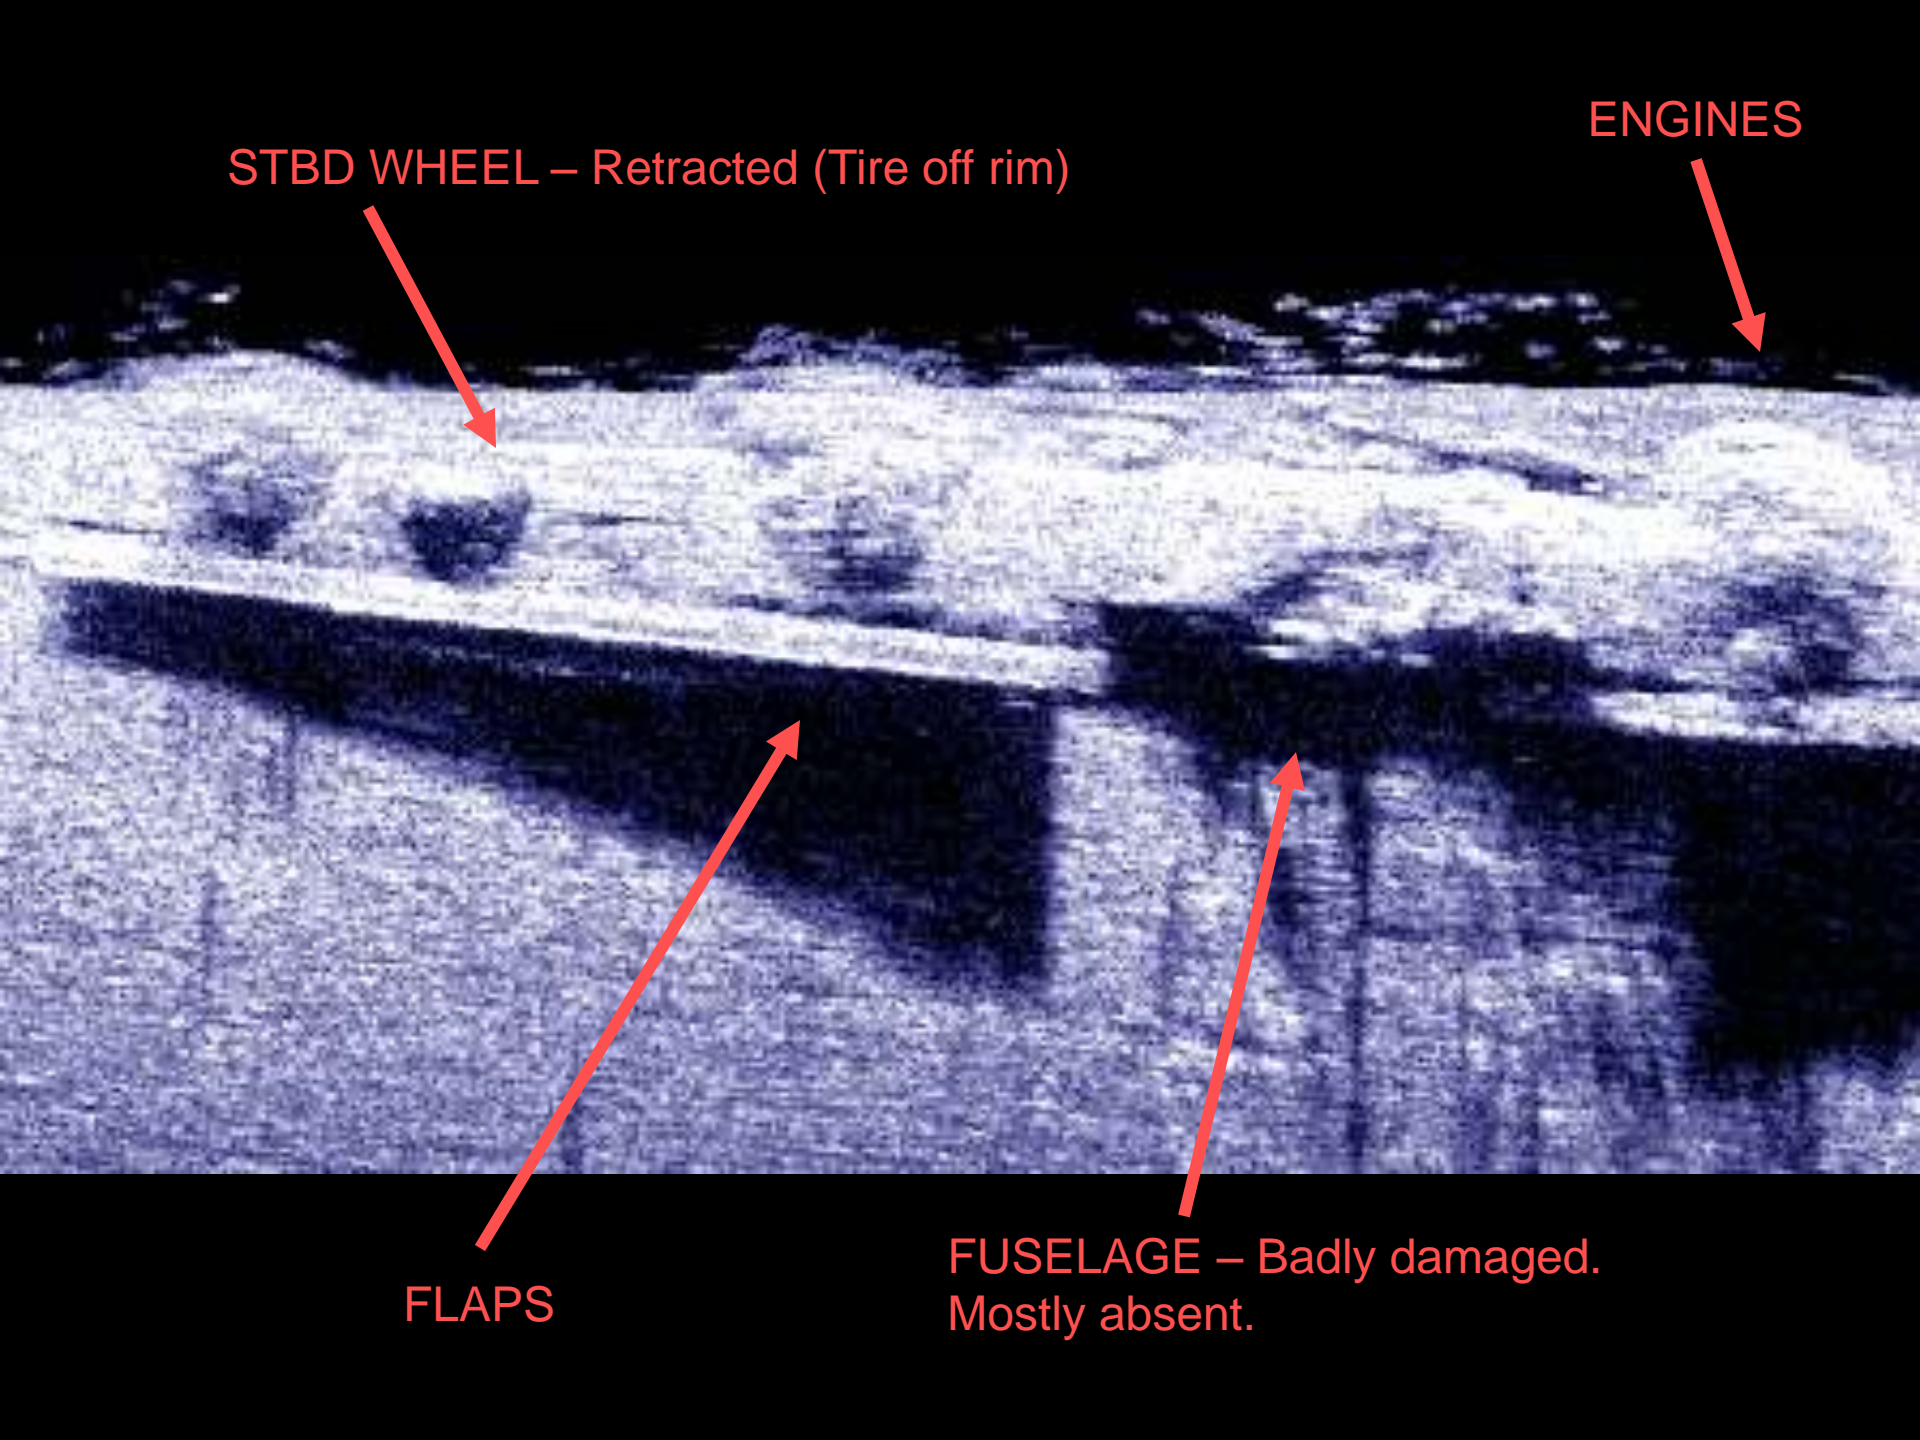
STBD WHEEL – Retracted (Tire off rim)

ENGINES

FLAPS

FUSELAGE – Badly damaged.
Mostly absent.

PORT WHEEL - Retracted

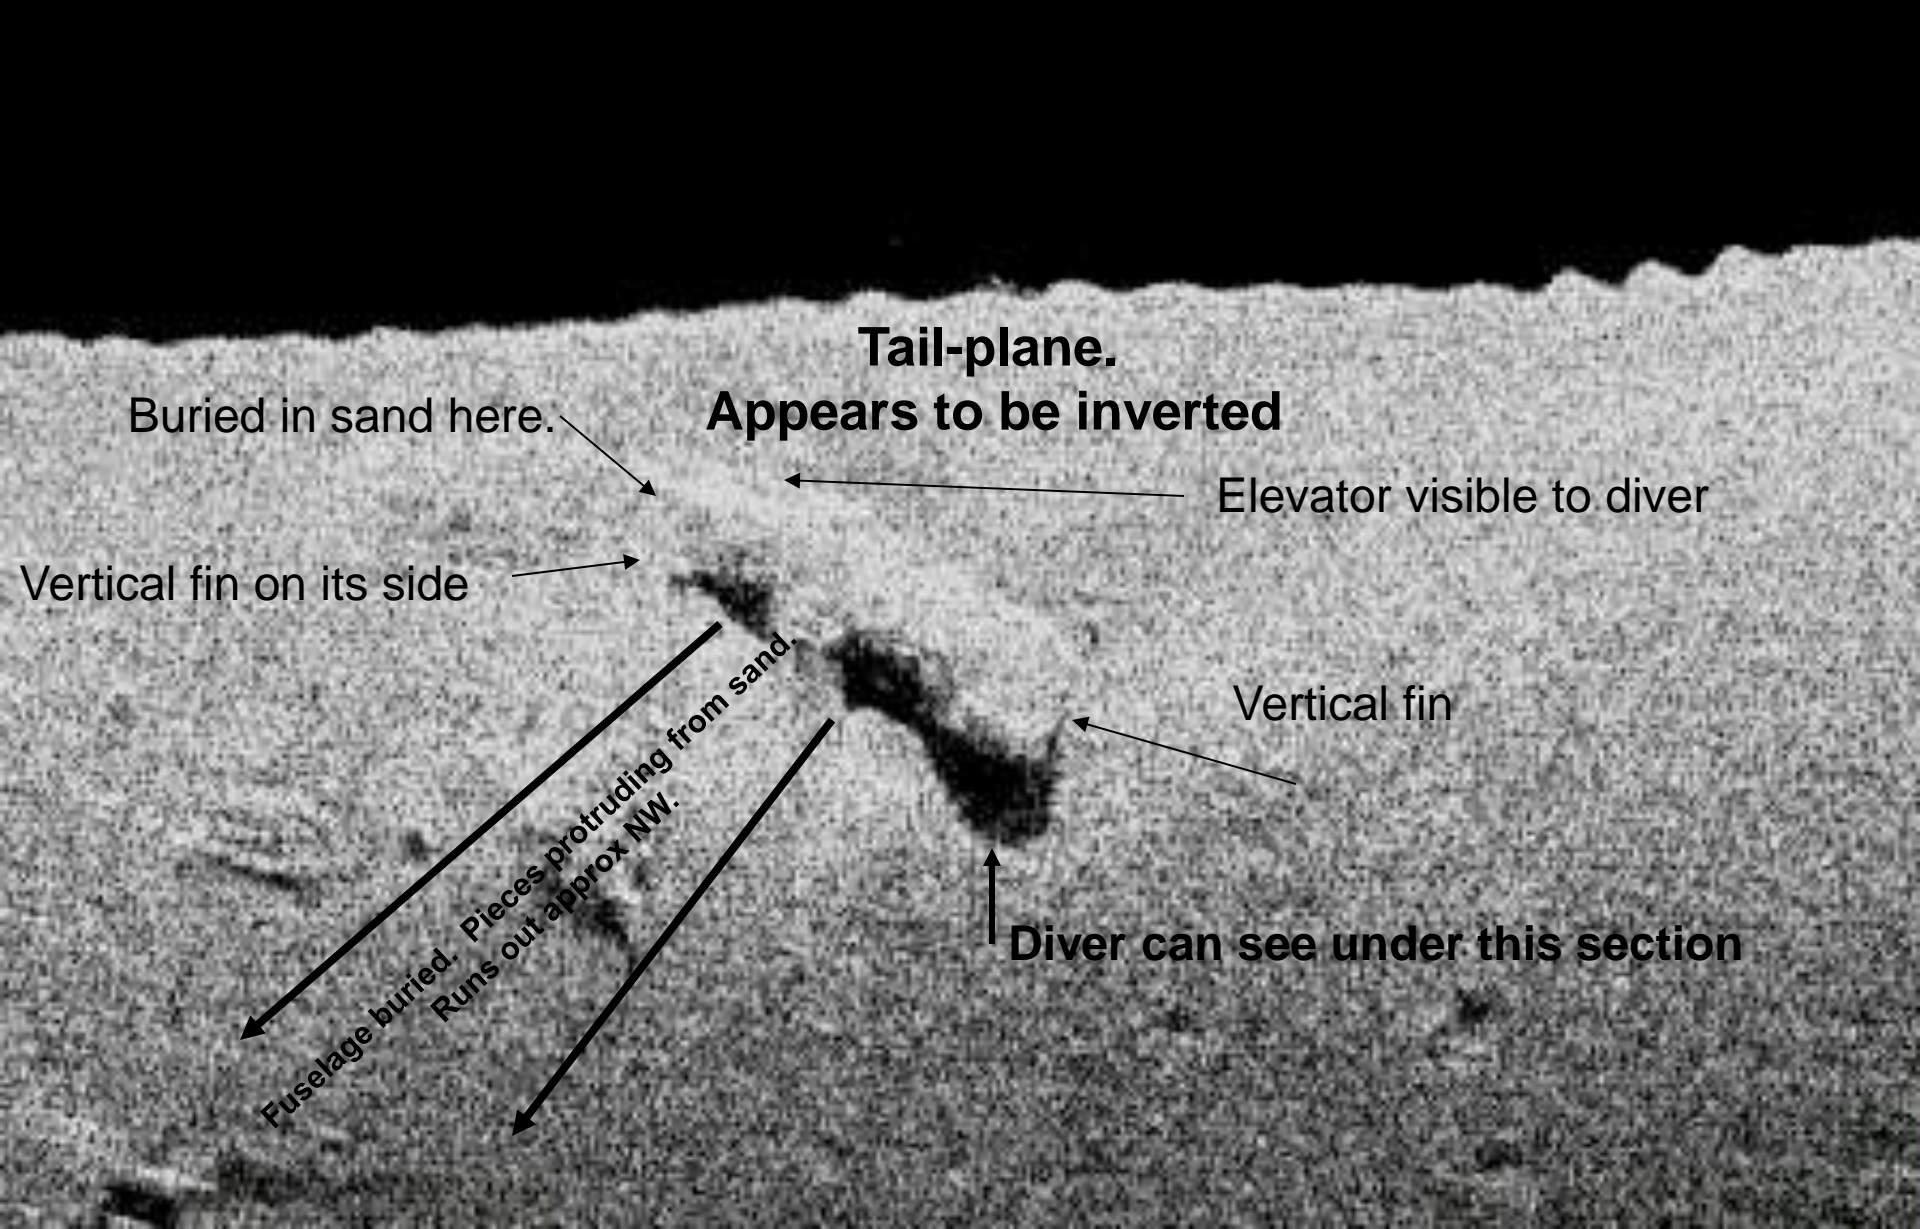
SITE LAYOUT

Buried in sand here.

Tail-plane.
Appears to be inverted

Elevator visible to diver

Vertical fin on its side

Vertical fin

Fuselage buried. Pieces protruding from sand.
Runs out approx NW.

Diver can see under this section

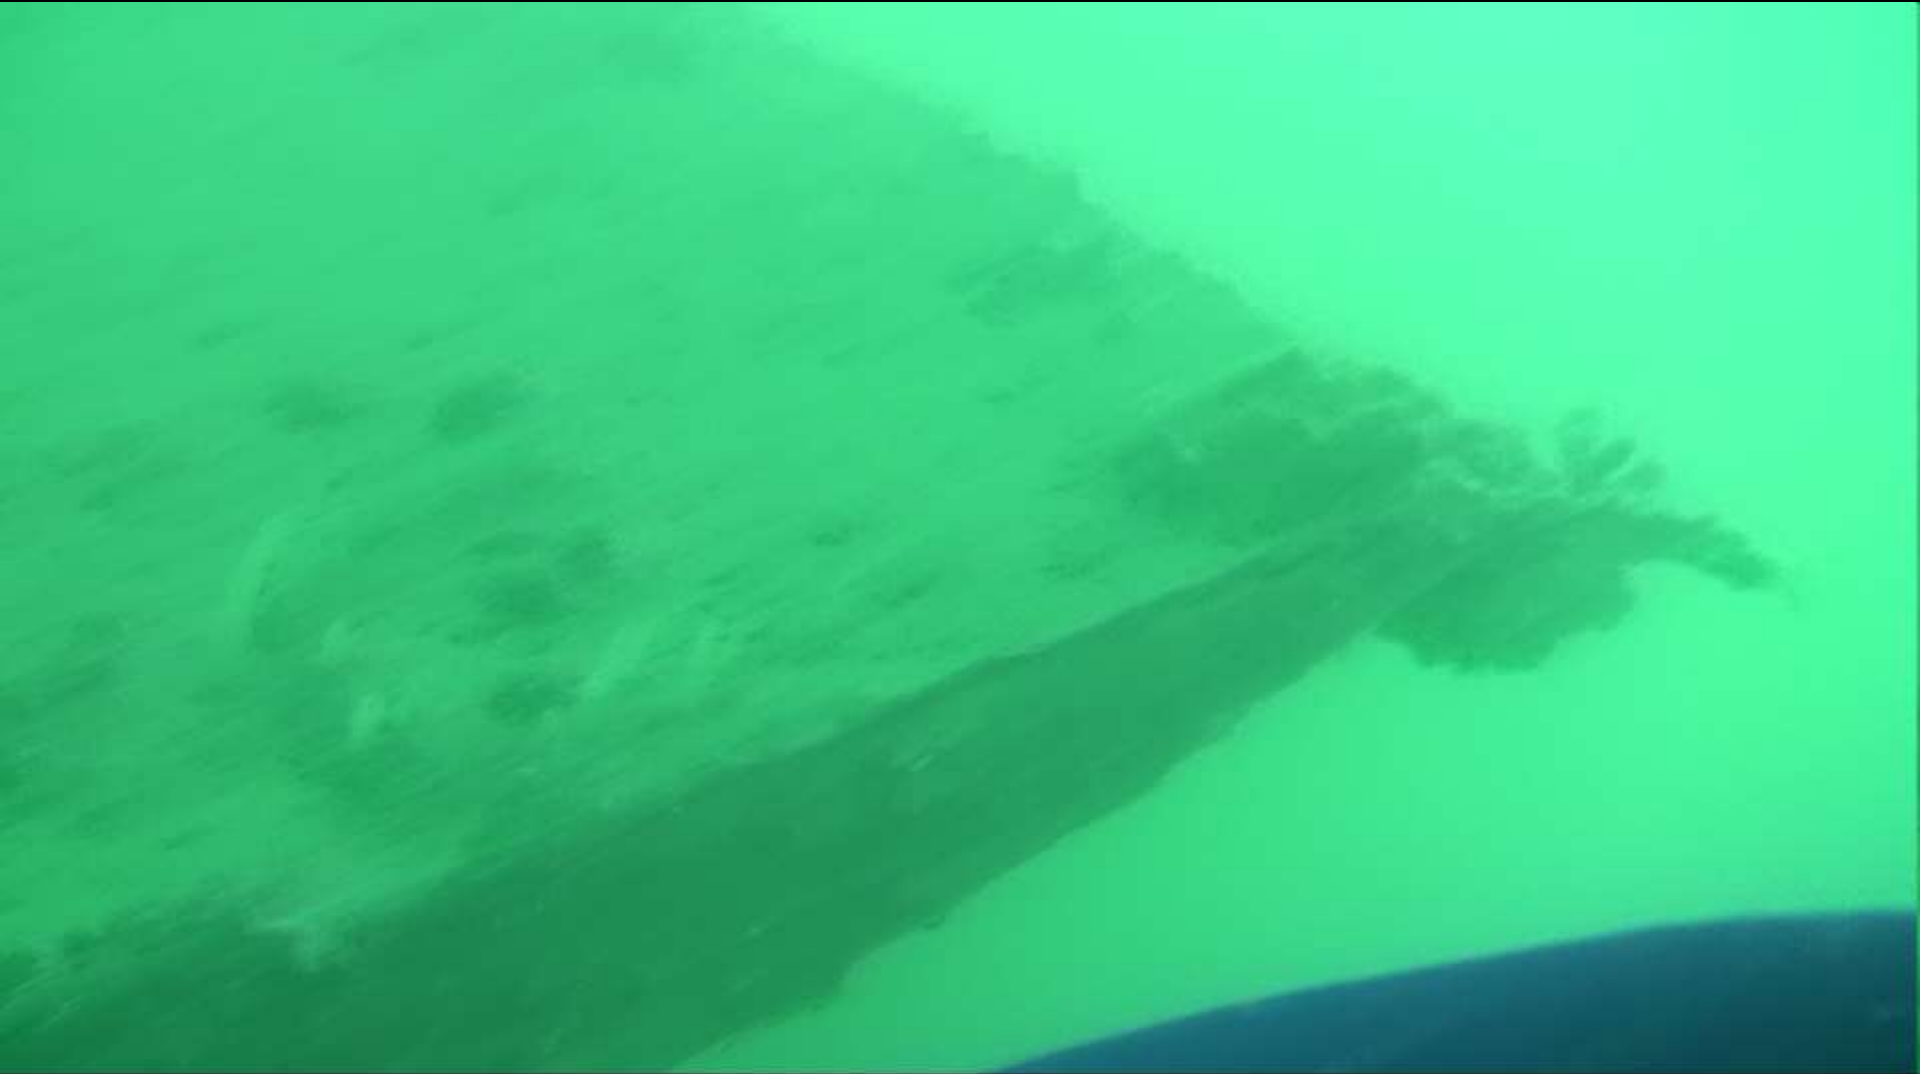
Starboard, Outboard End of Flap

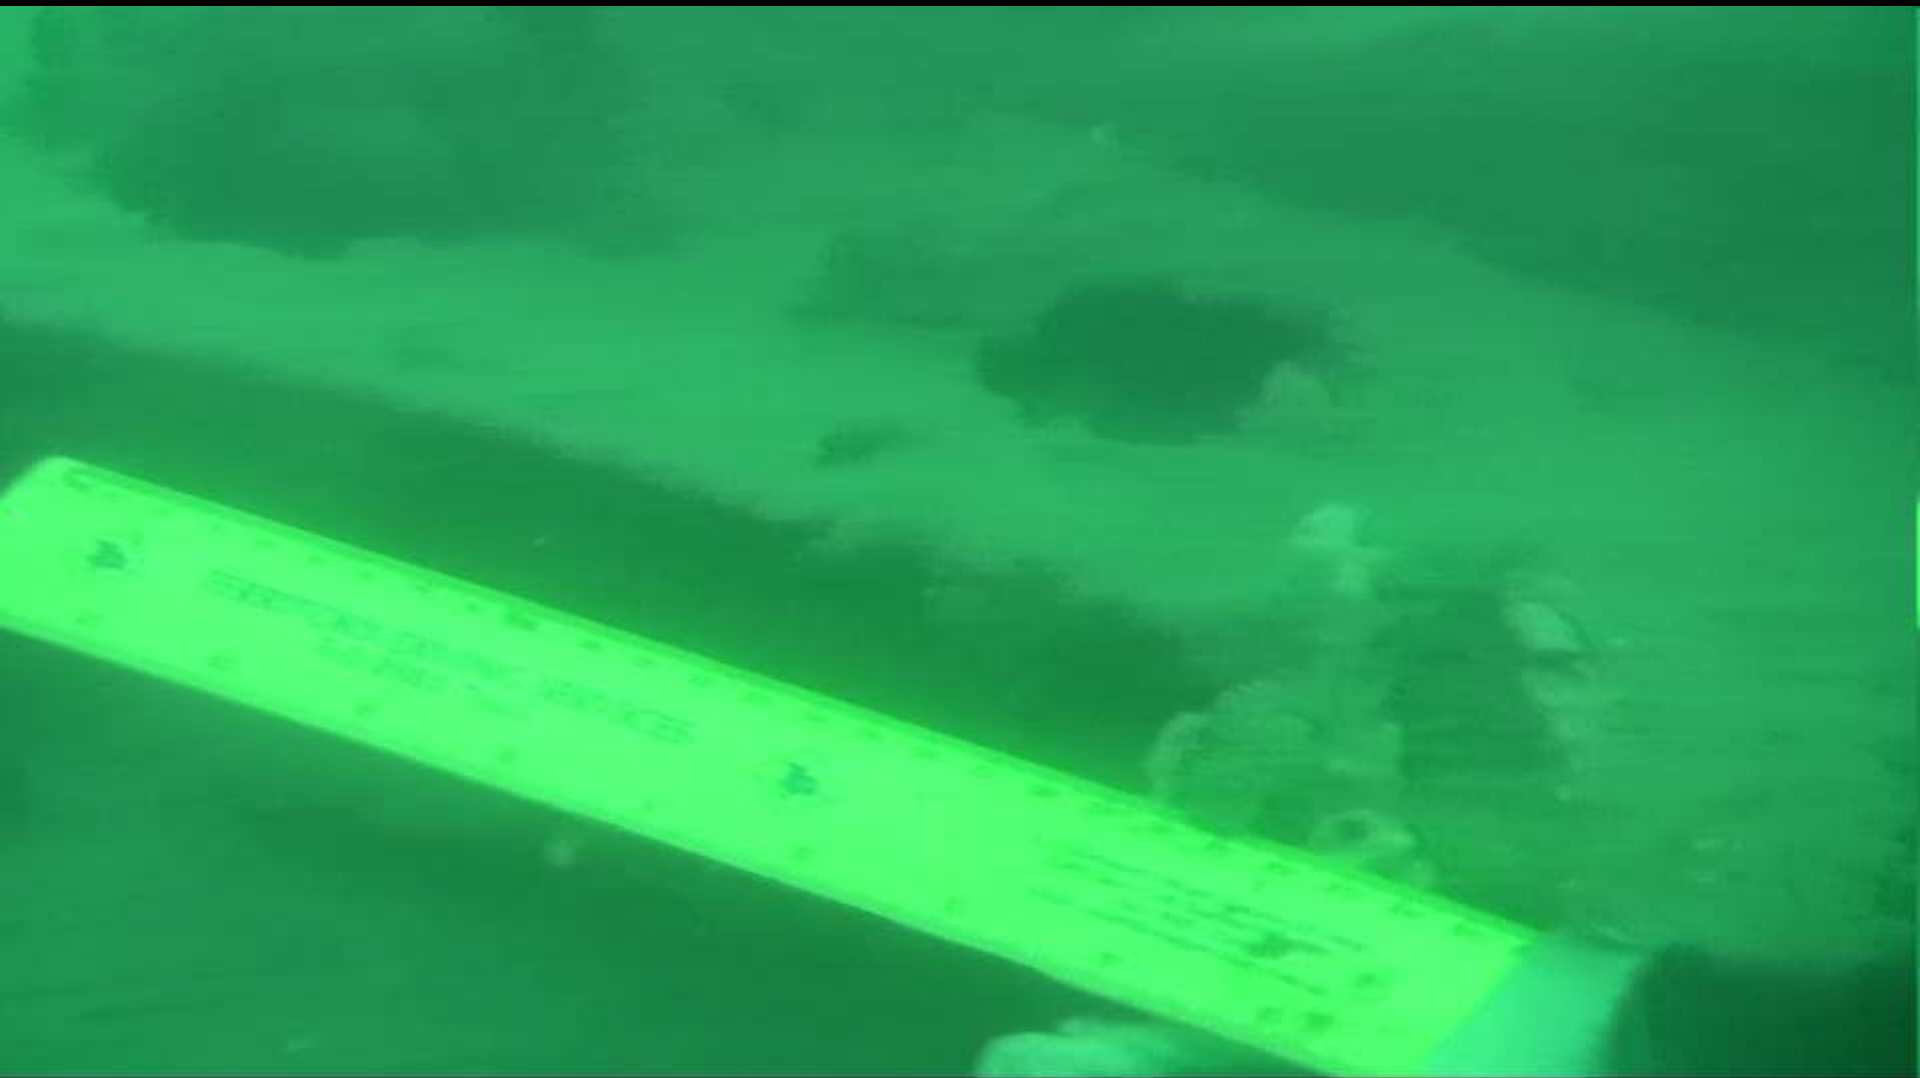
Starboard, Aileron, Inboard End. (Originally fabric covered?)

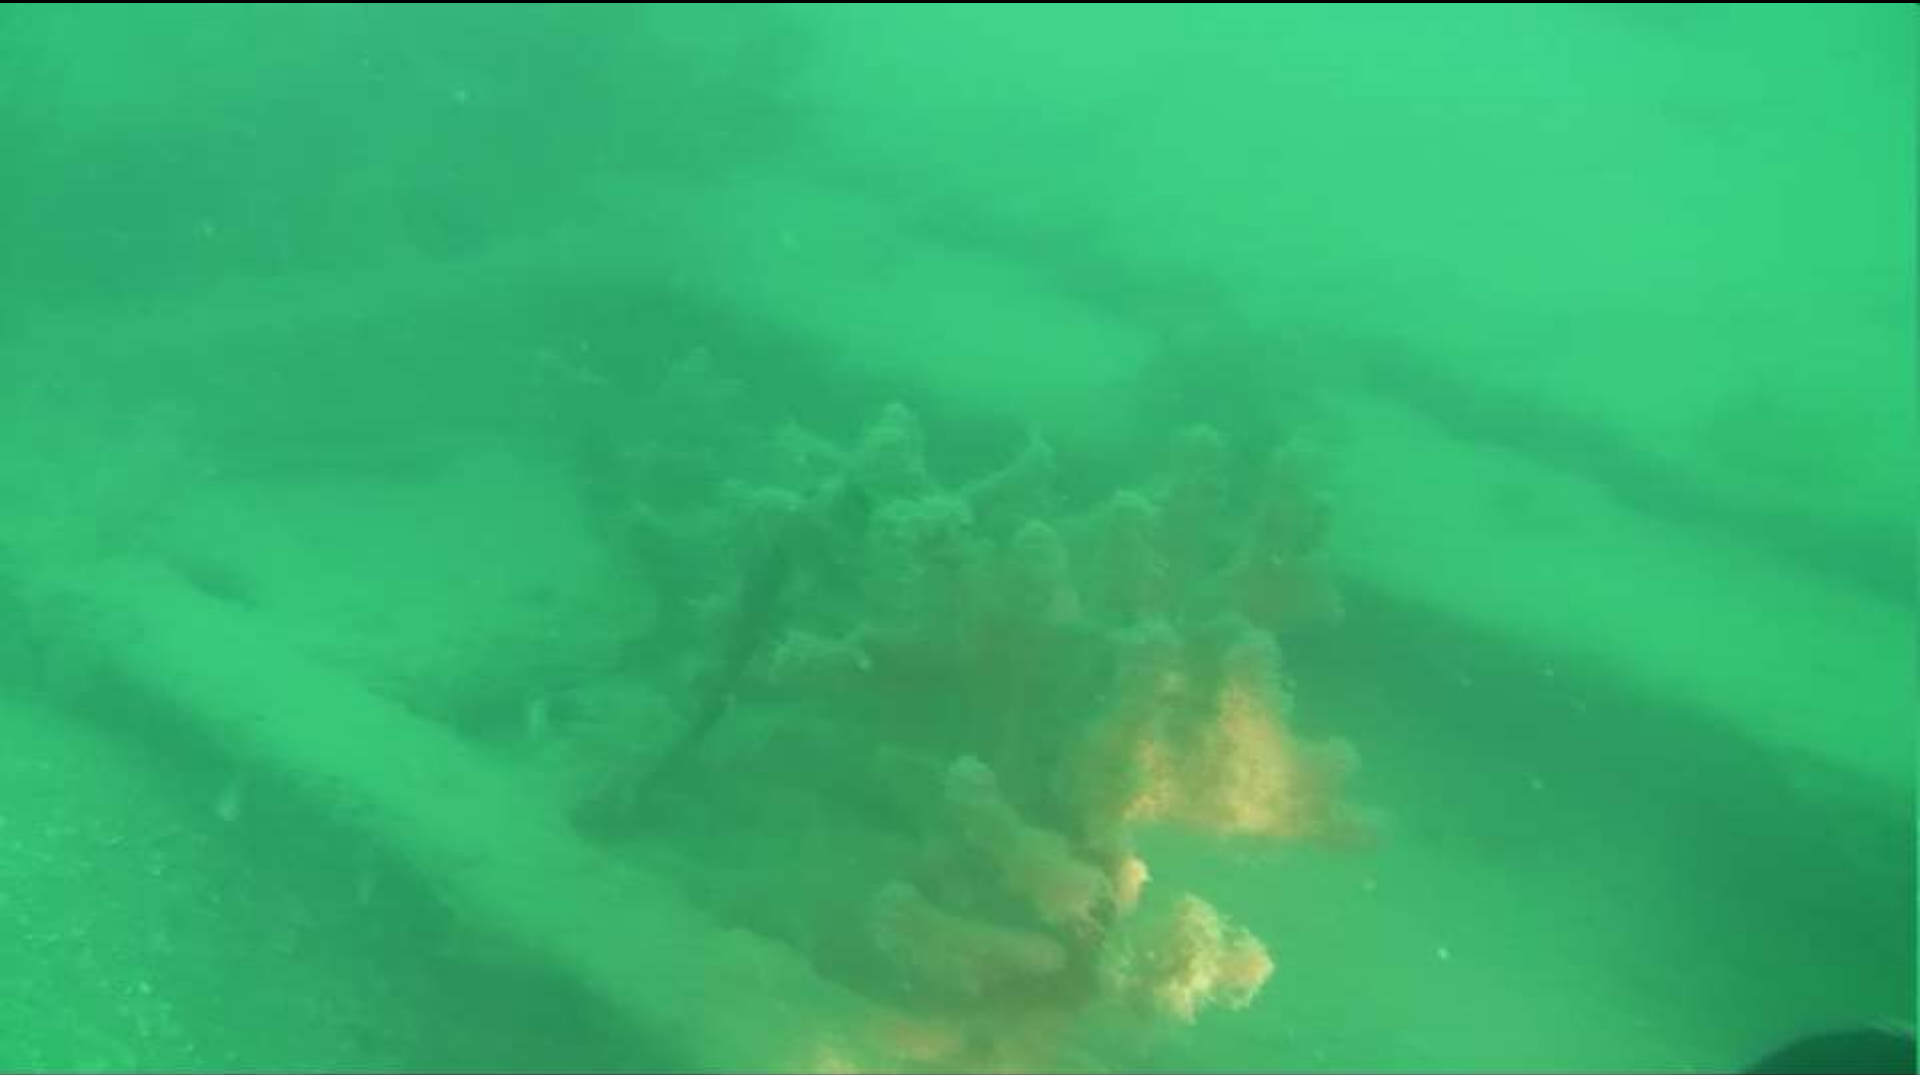
Starboard Aileron and Wing Join

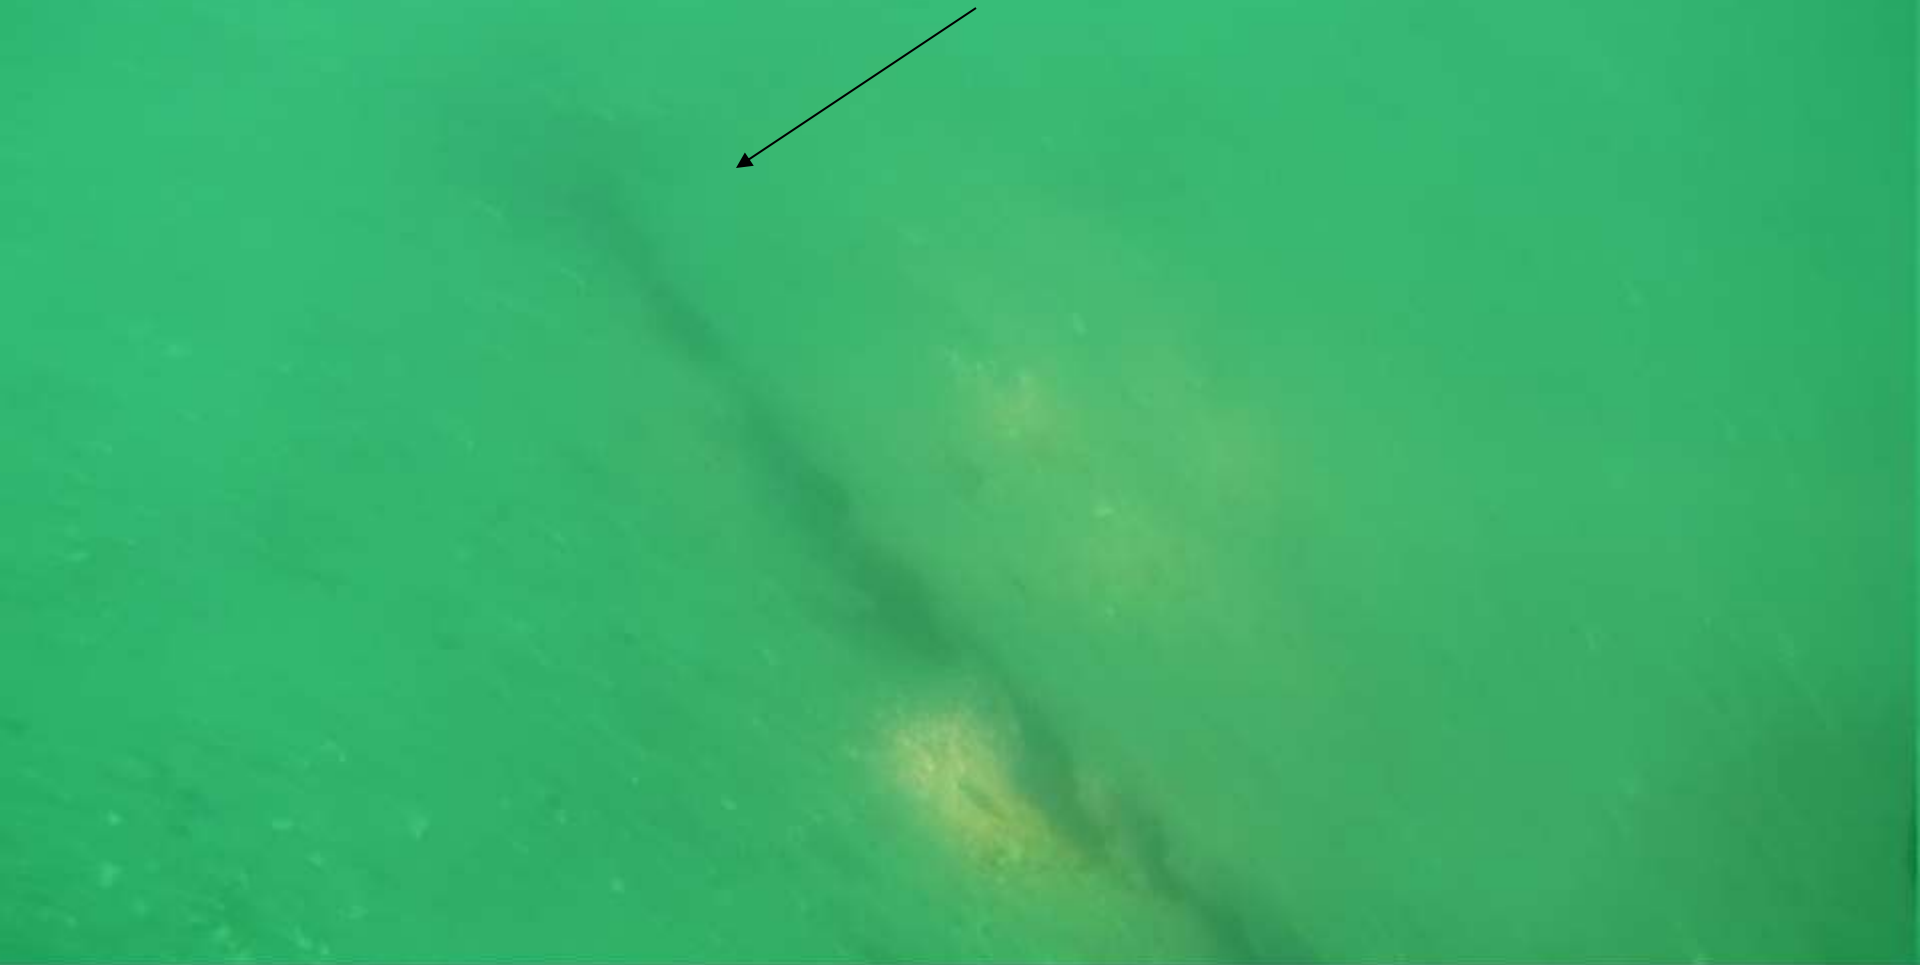
Curved, Starboard Wingtip Entering Thin Layer of Sand

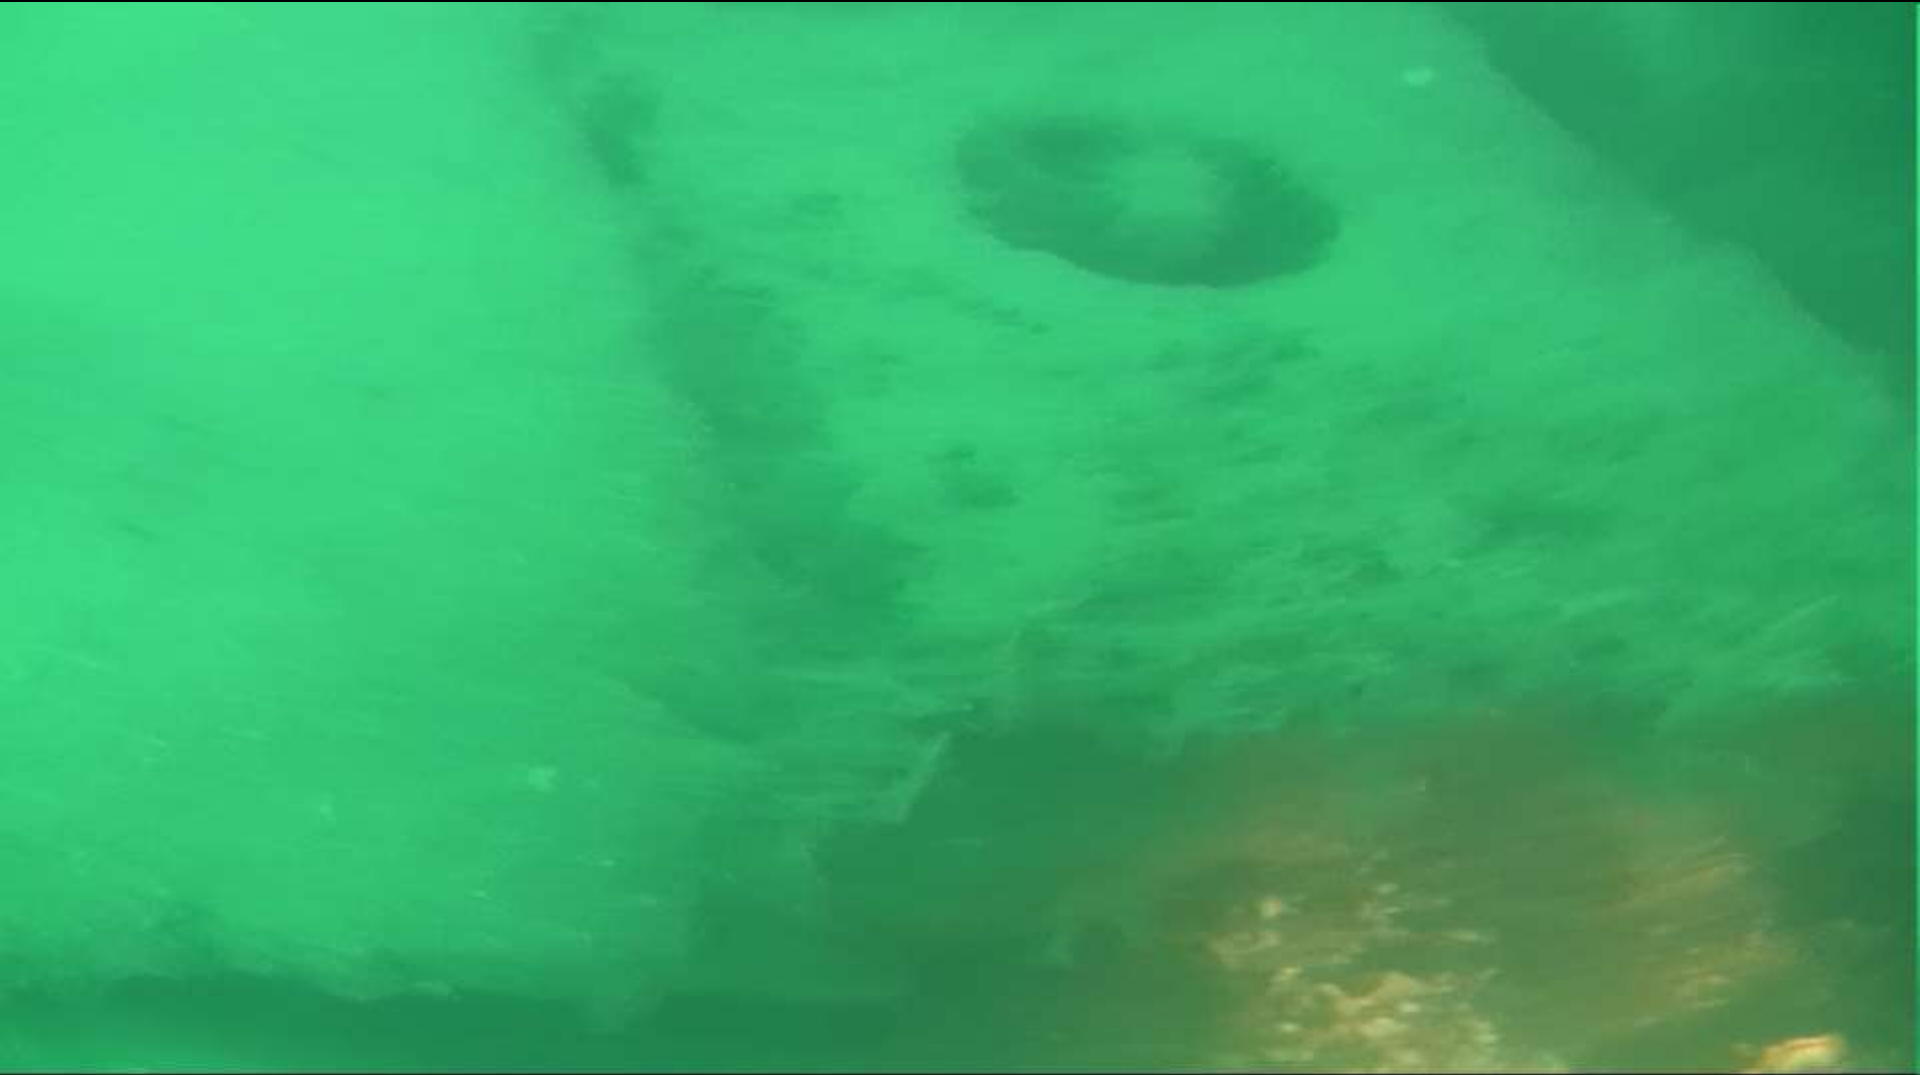
Starboard Aileron and Wingtip Join
