B24 Liberator A72-80 Underwater Dive Inspection Truscott WA Discovered 17-18 Aug 2009

B-24 Liberator

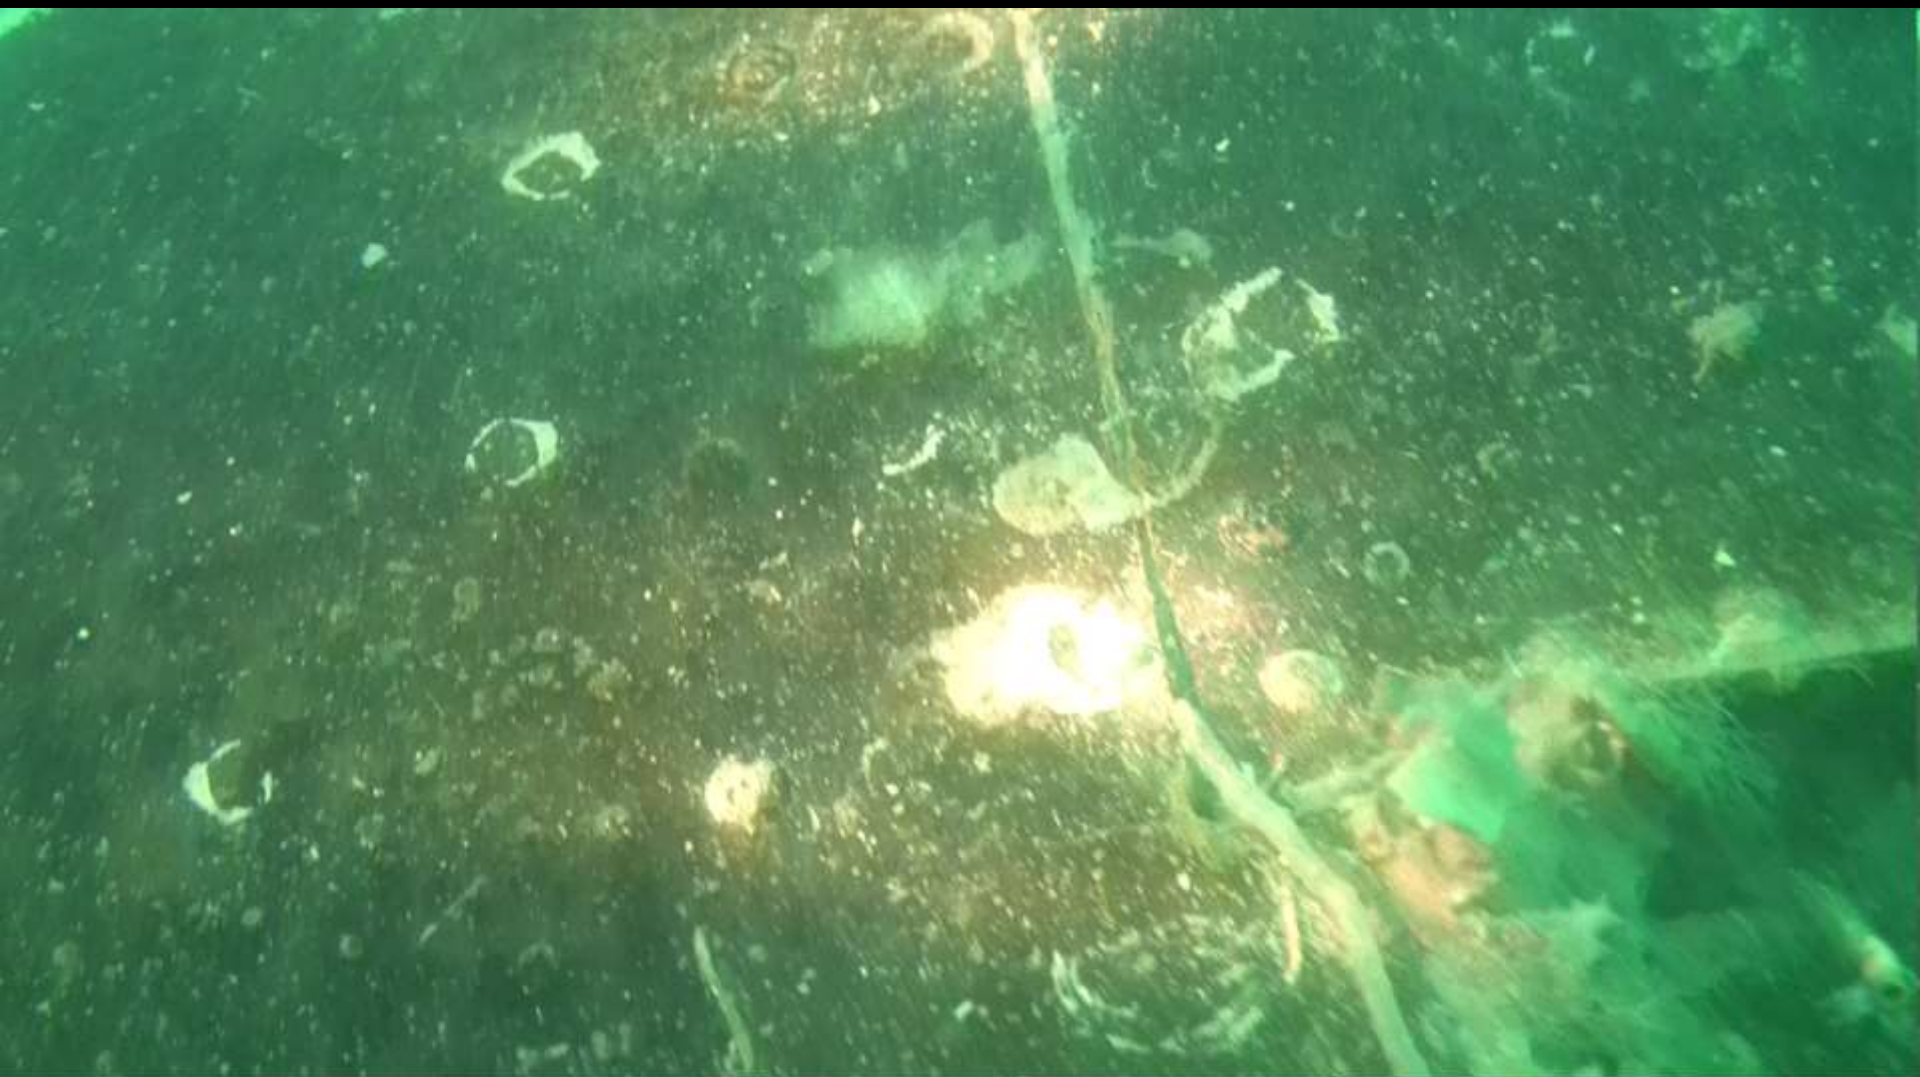
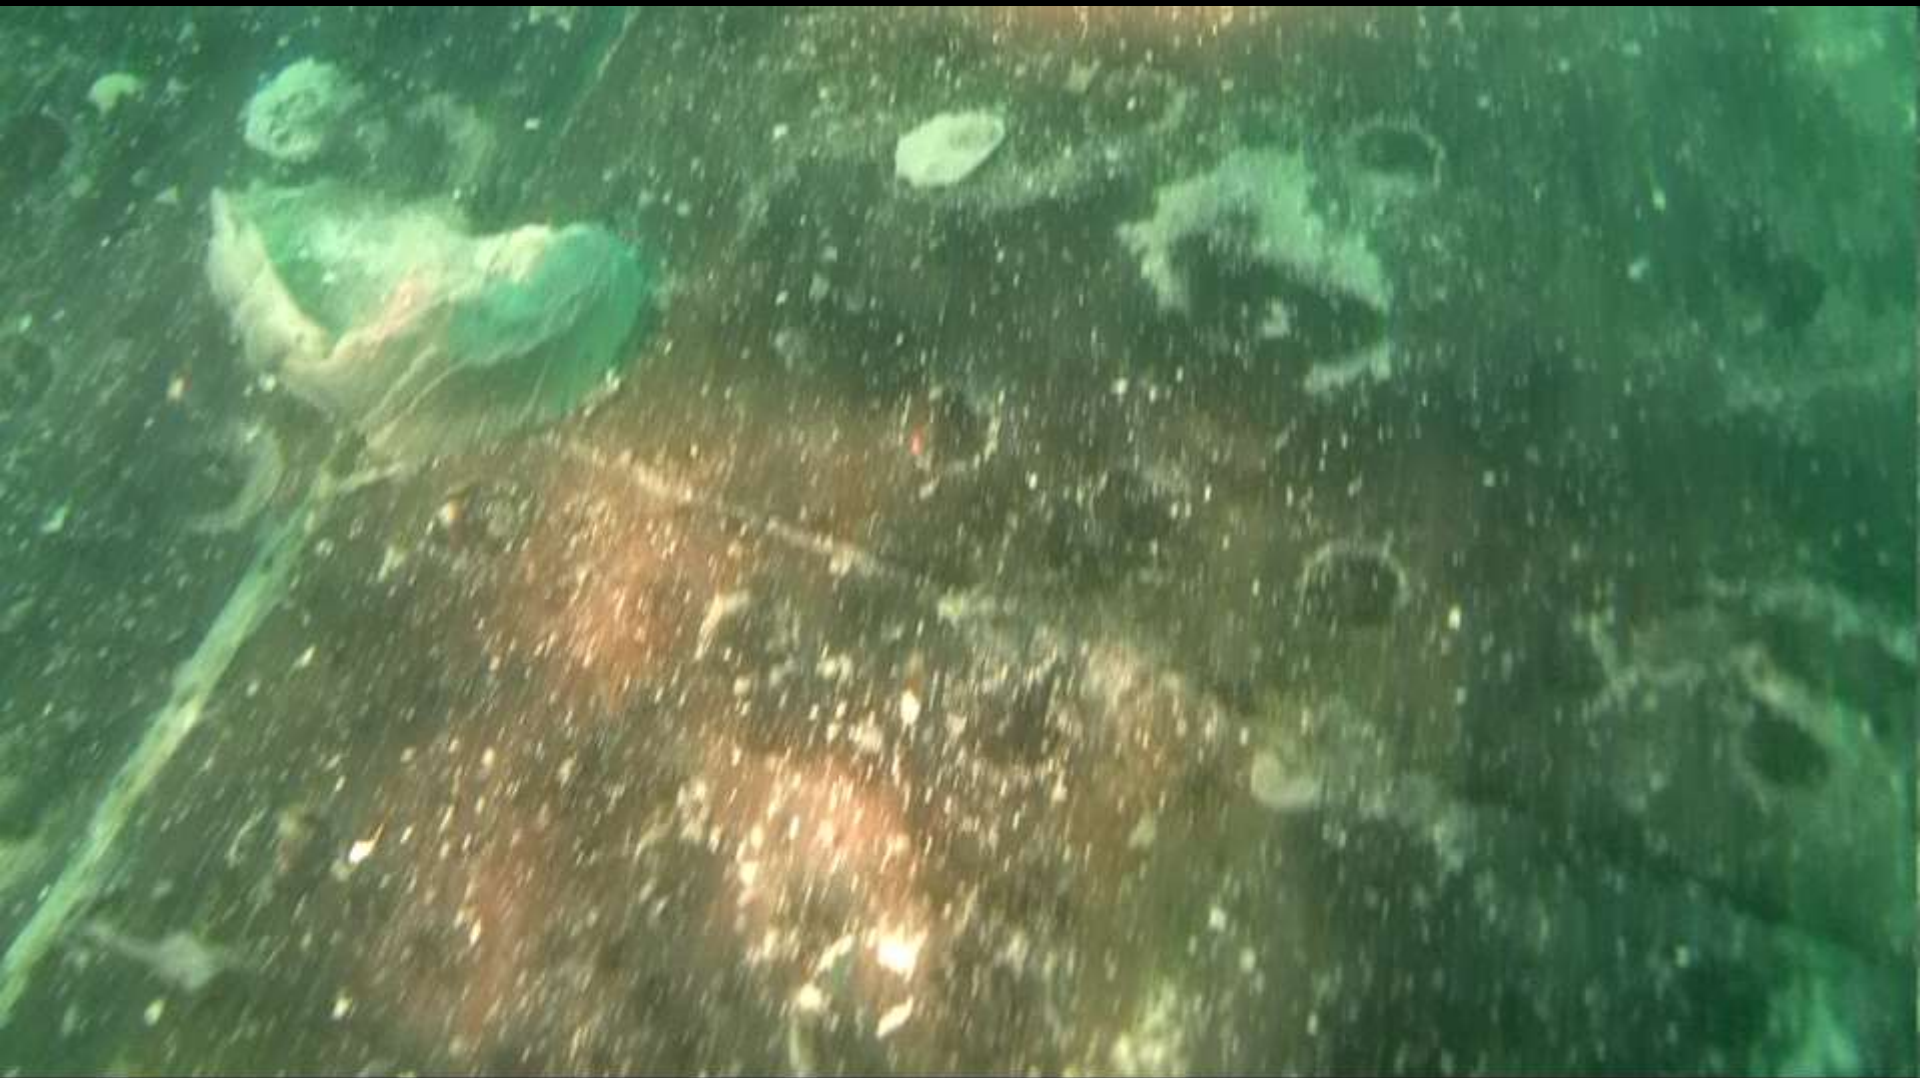
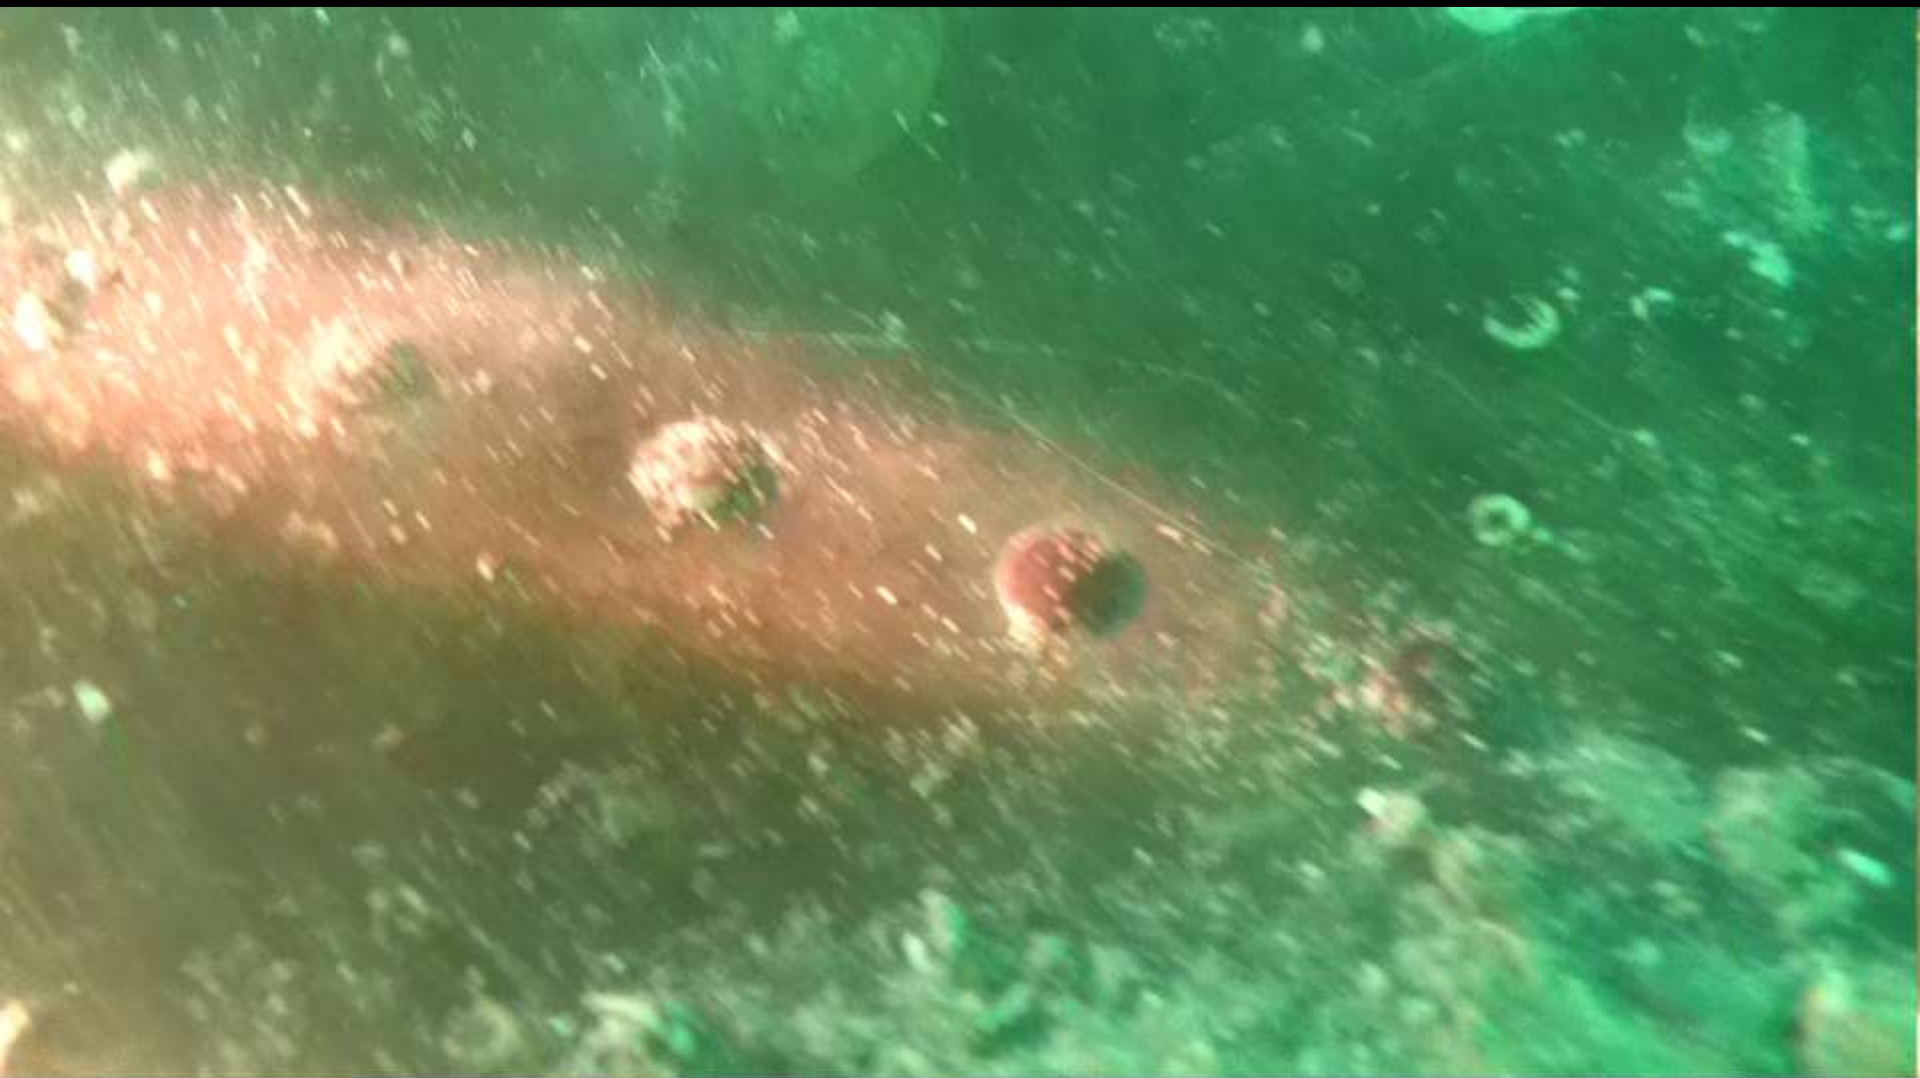
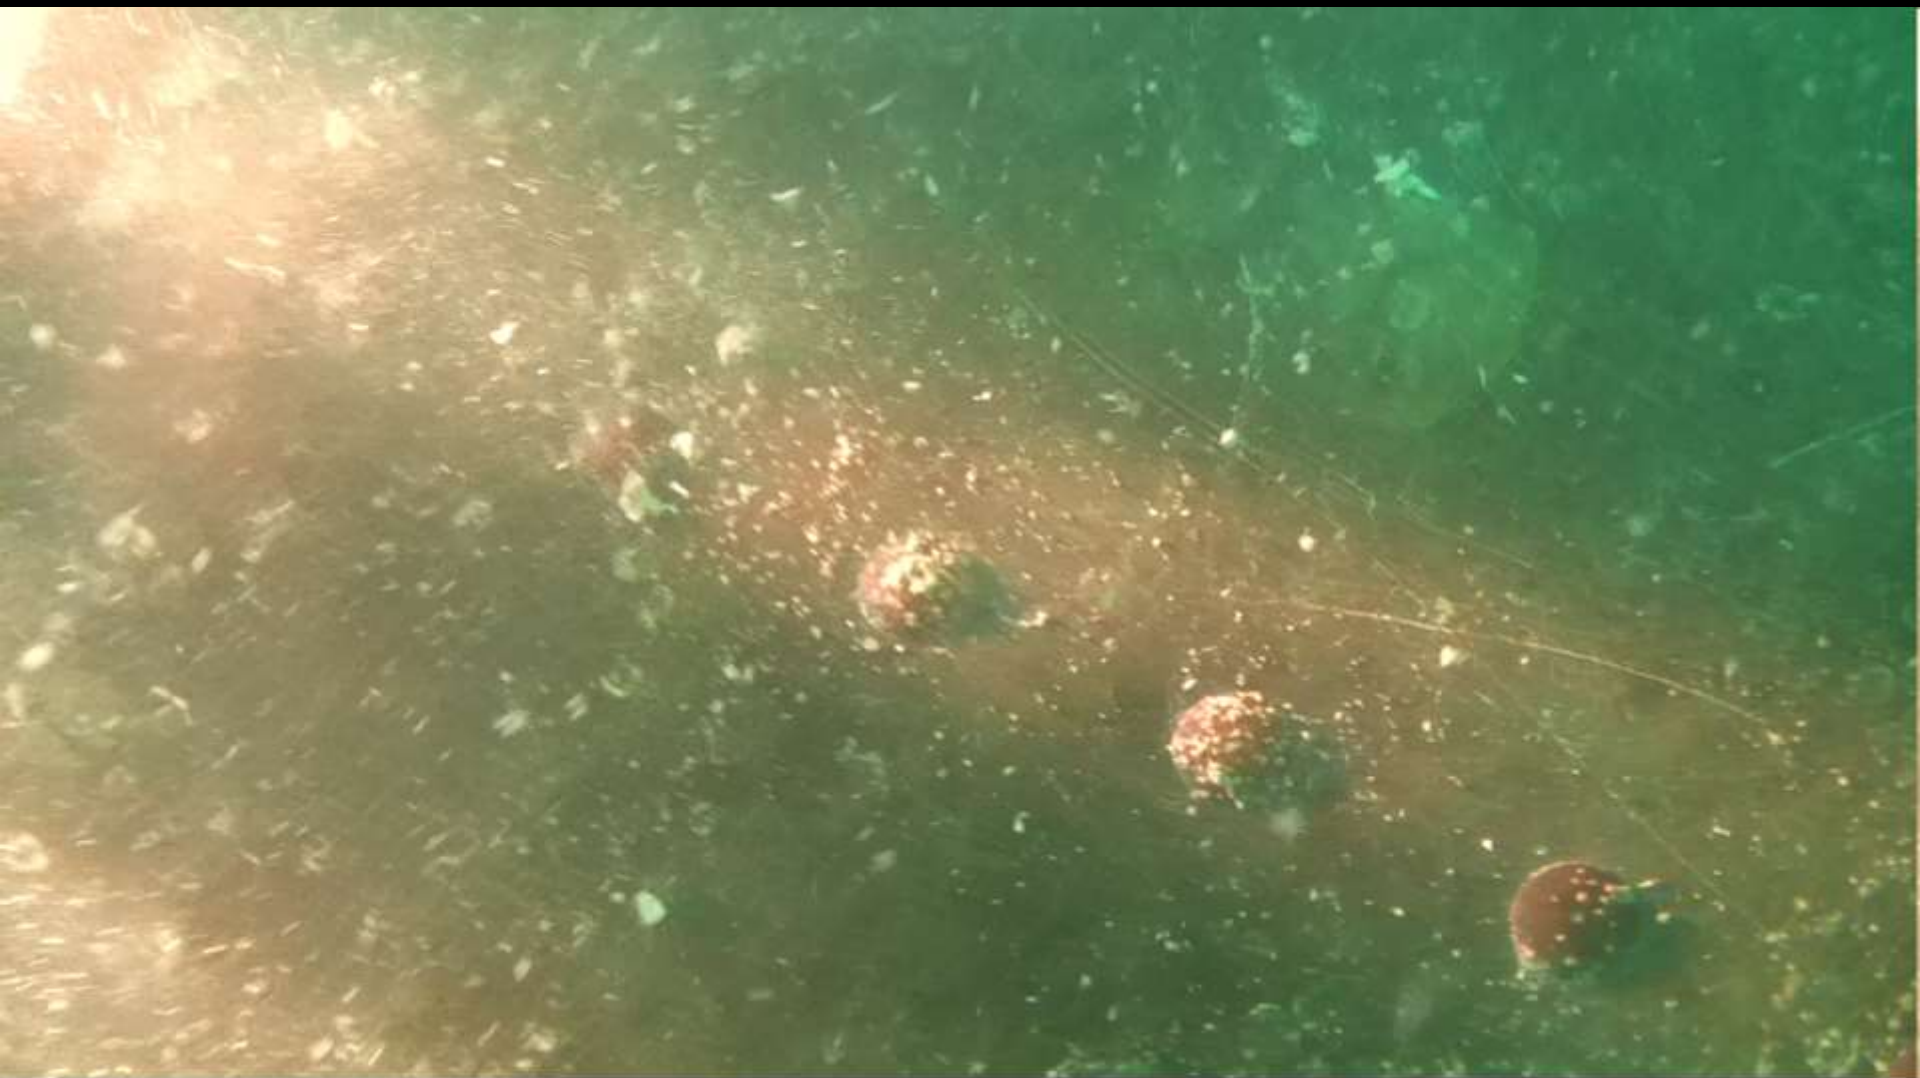
Starboard Wingtip; Sand Cleaned Away. Black Paint?

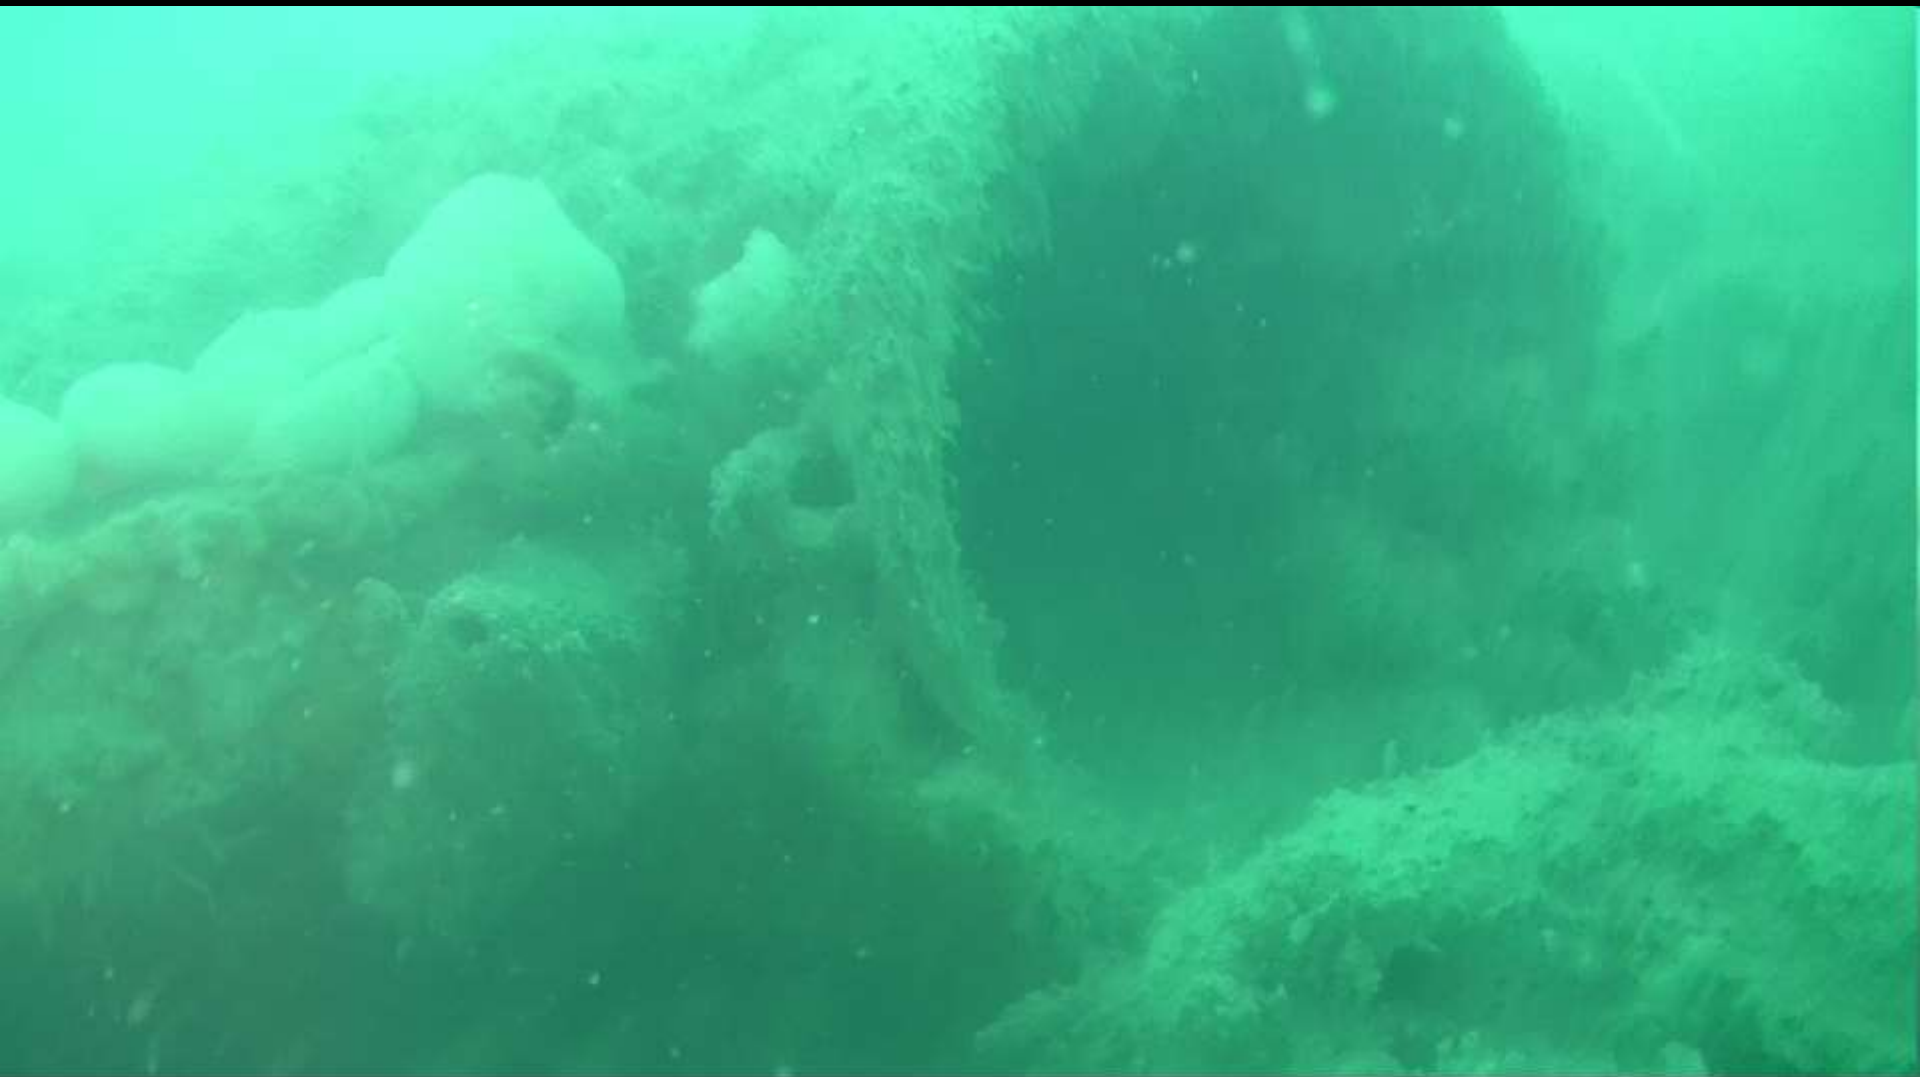
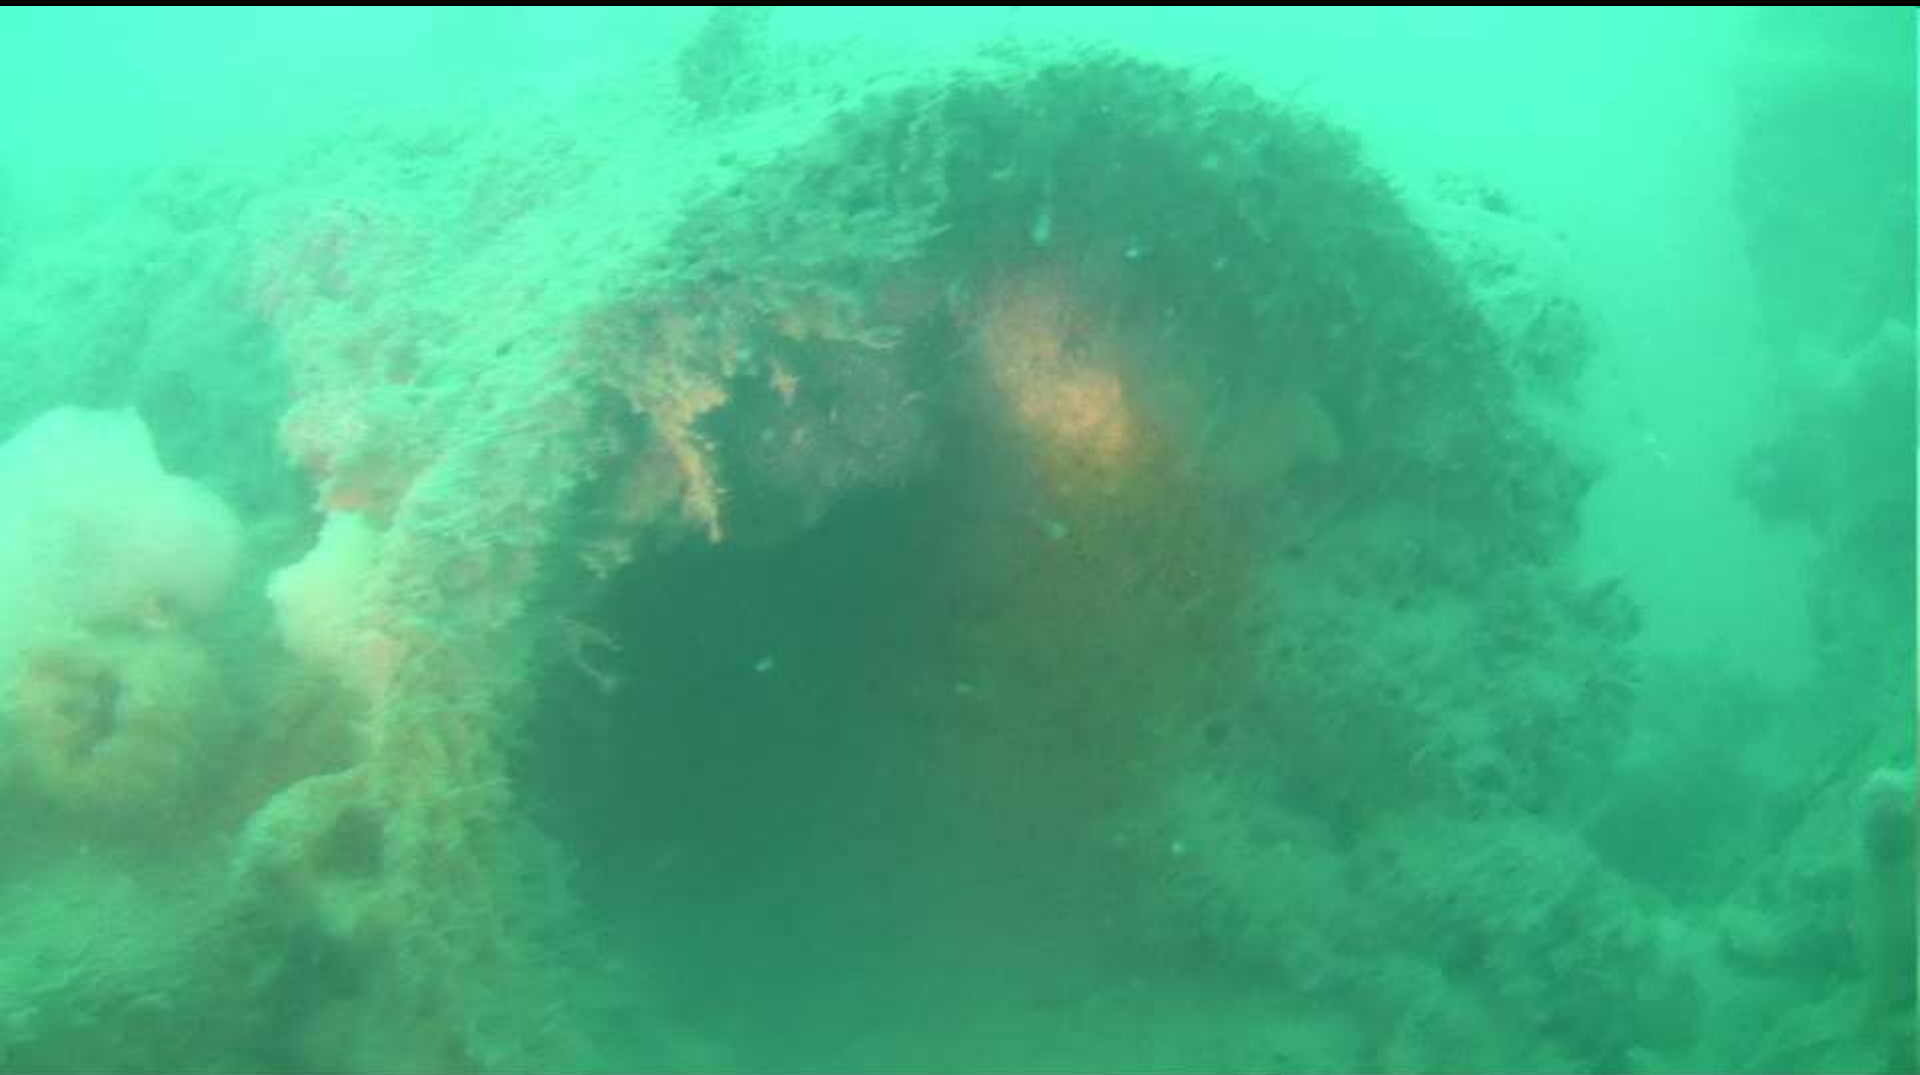
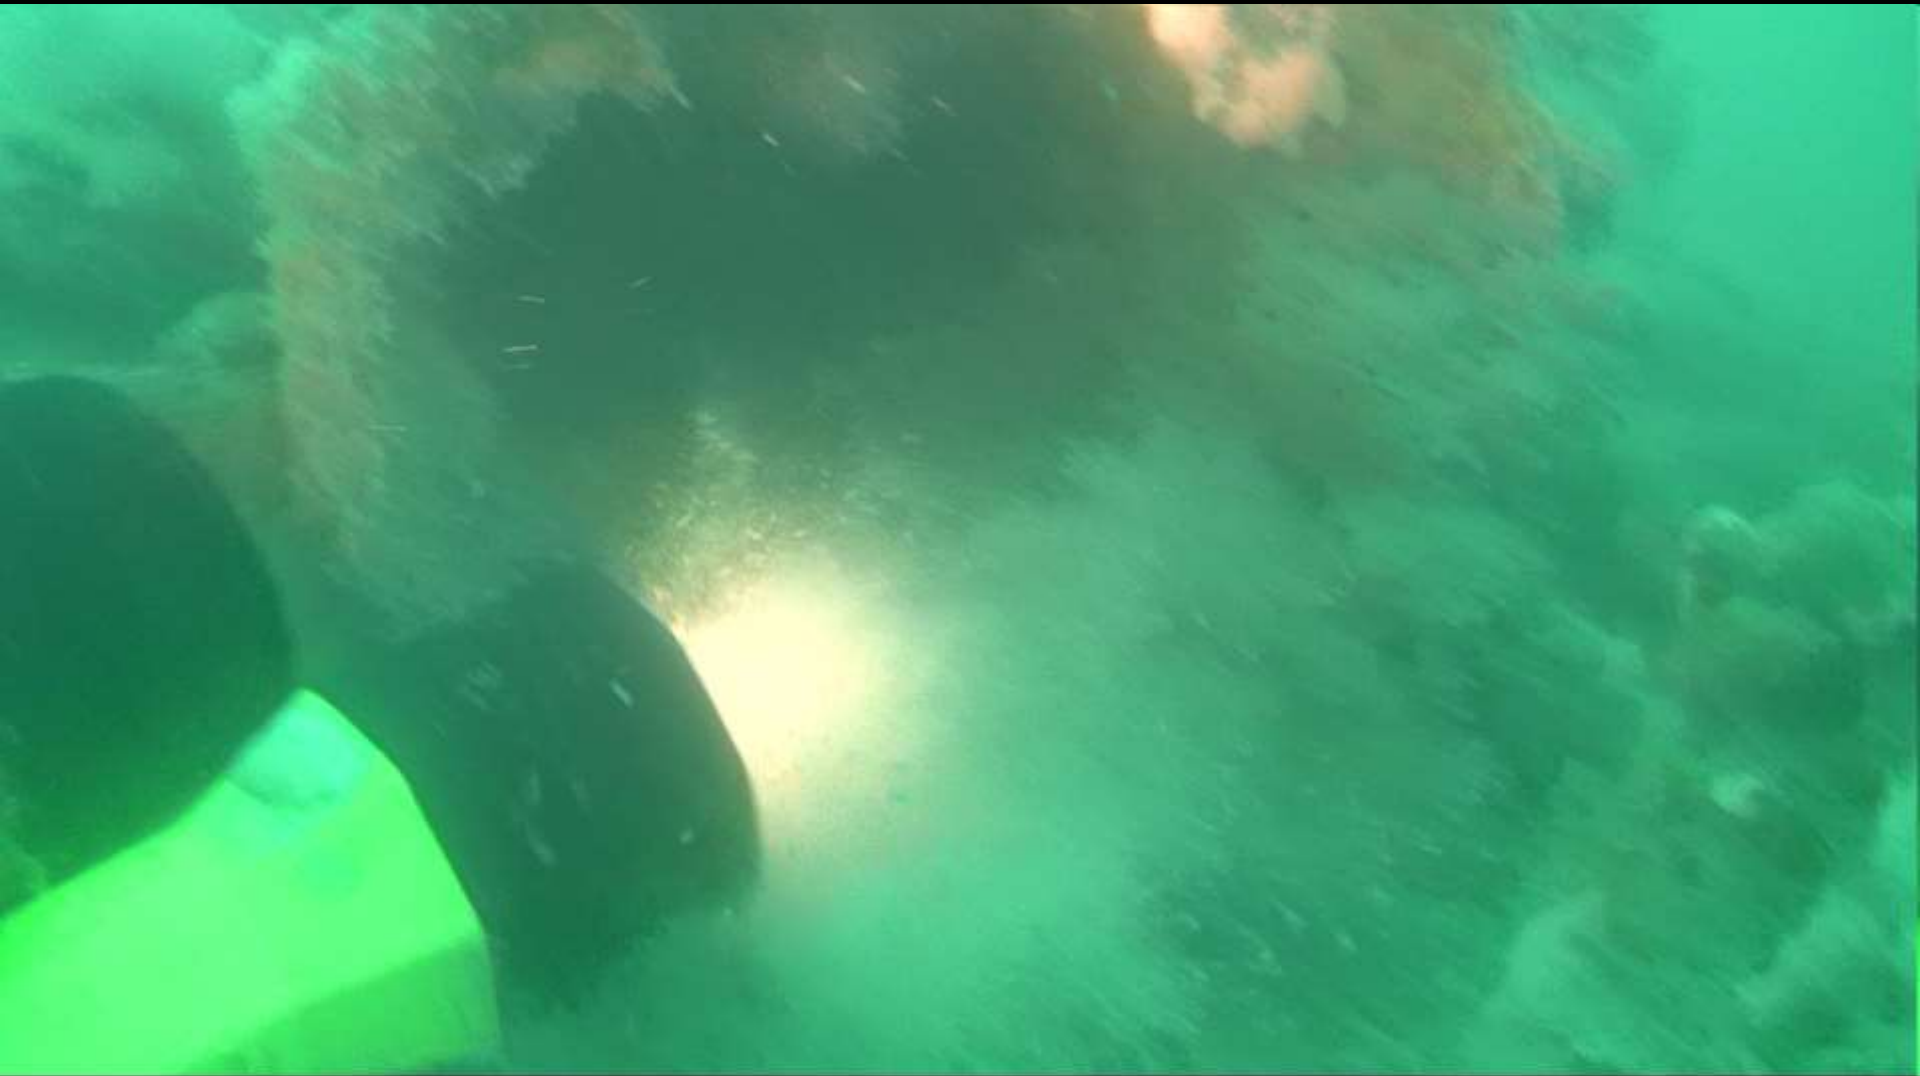
Starboard Outboard Engine Exhaust

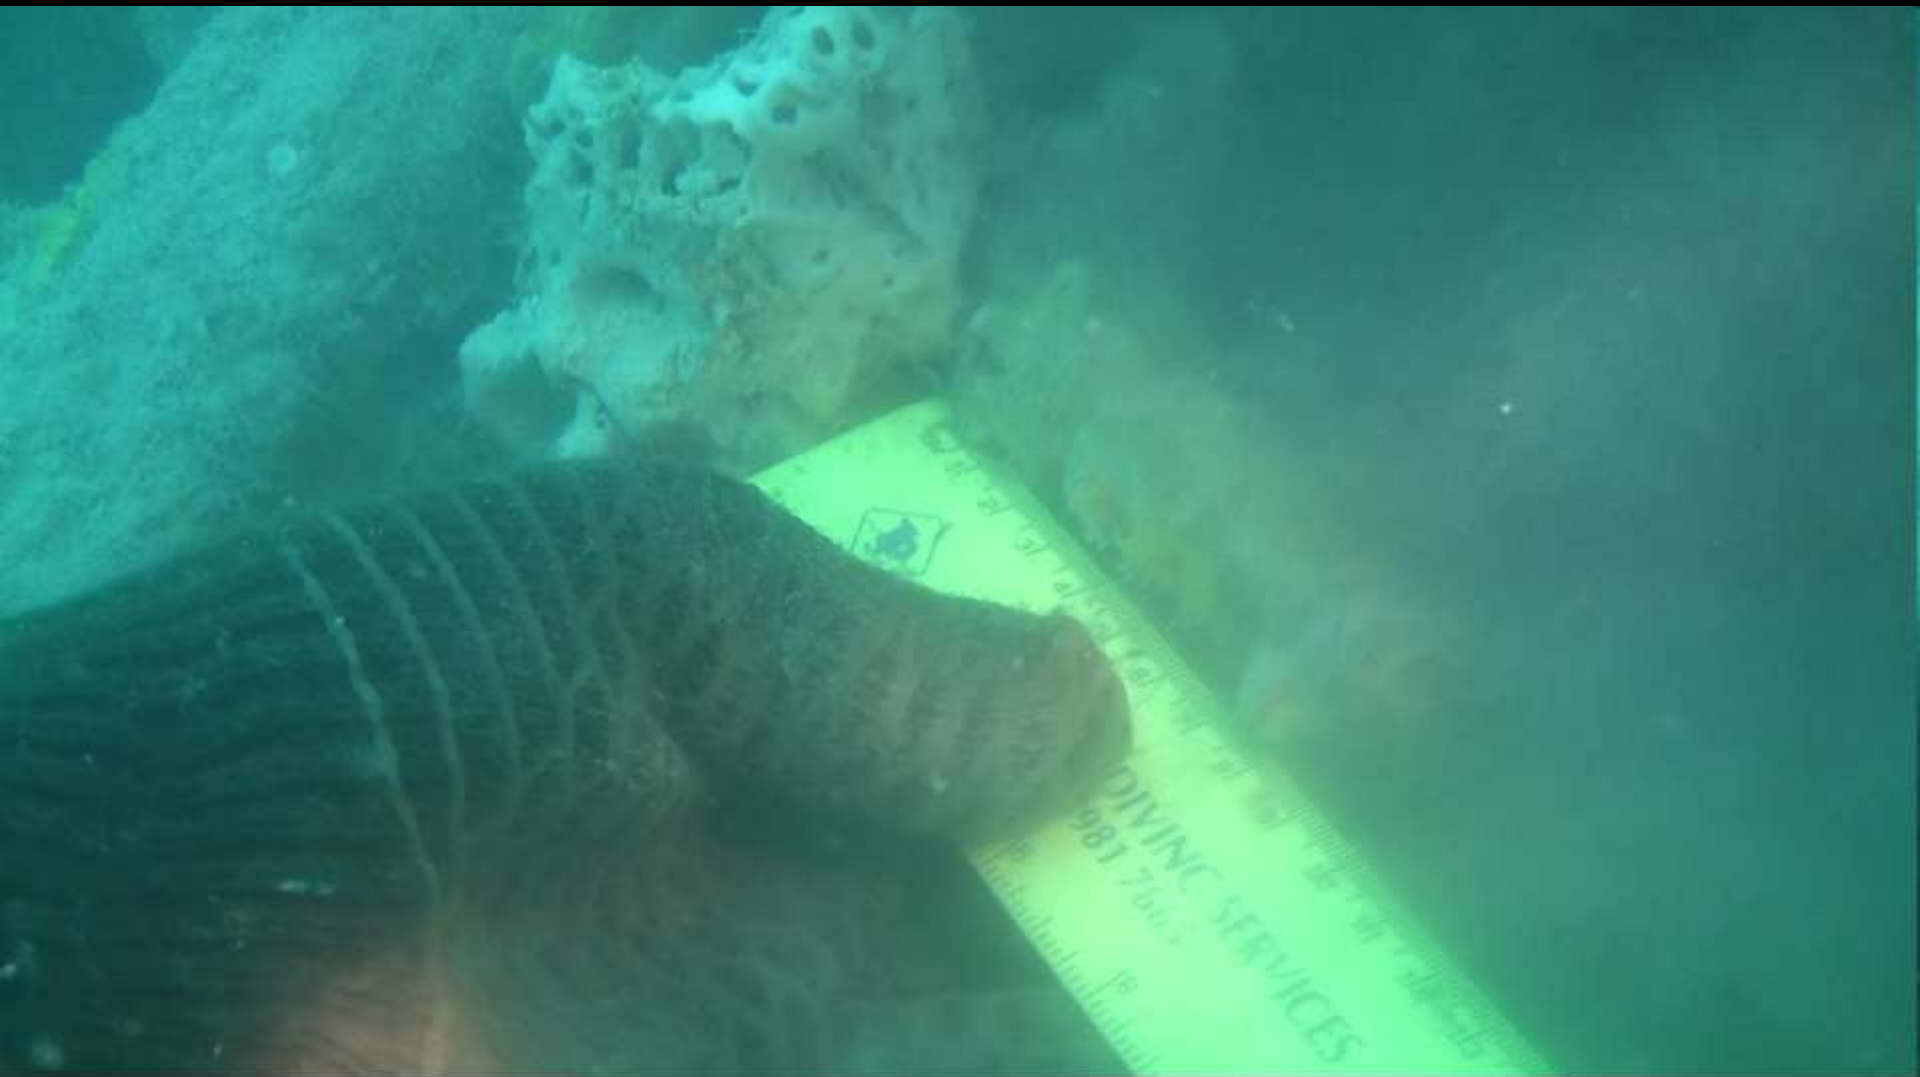
Starboard Wheel; Inflator Valve

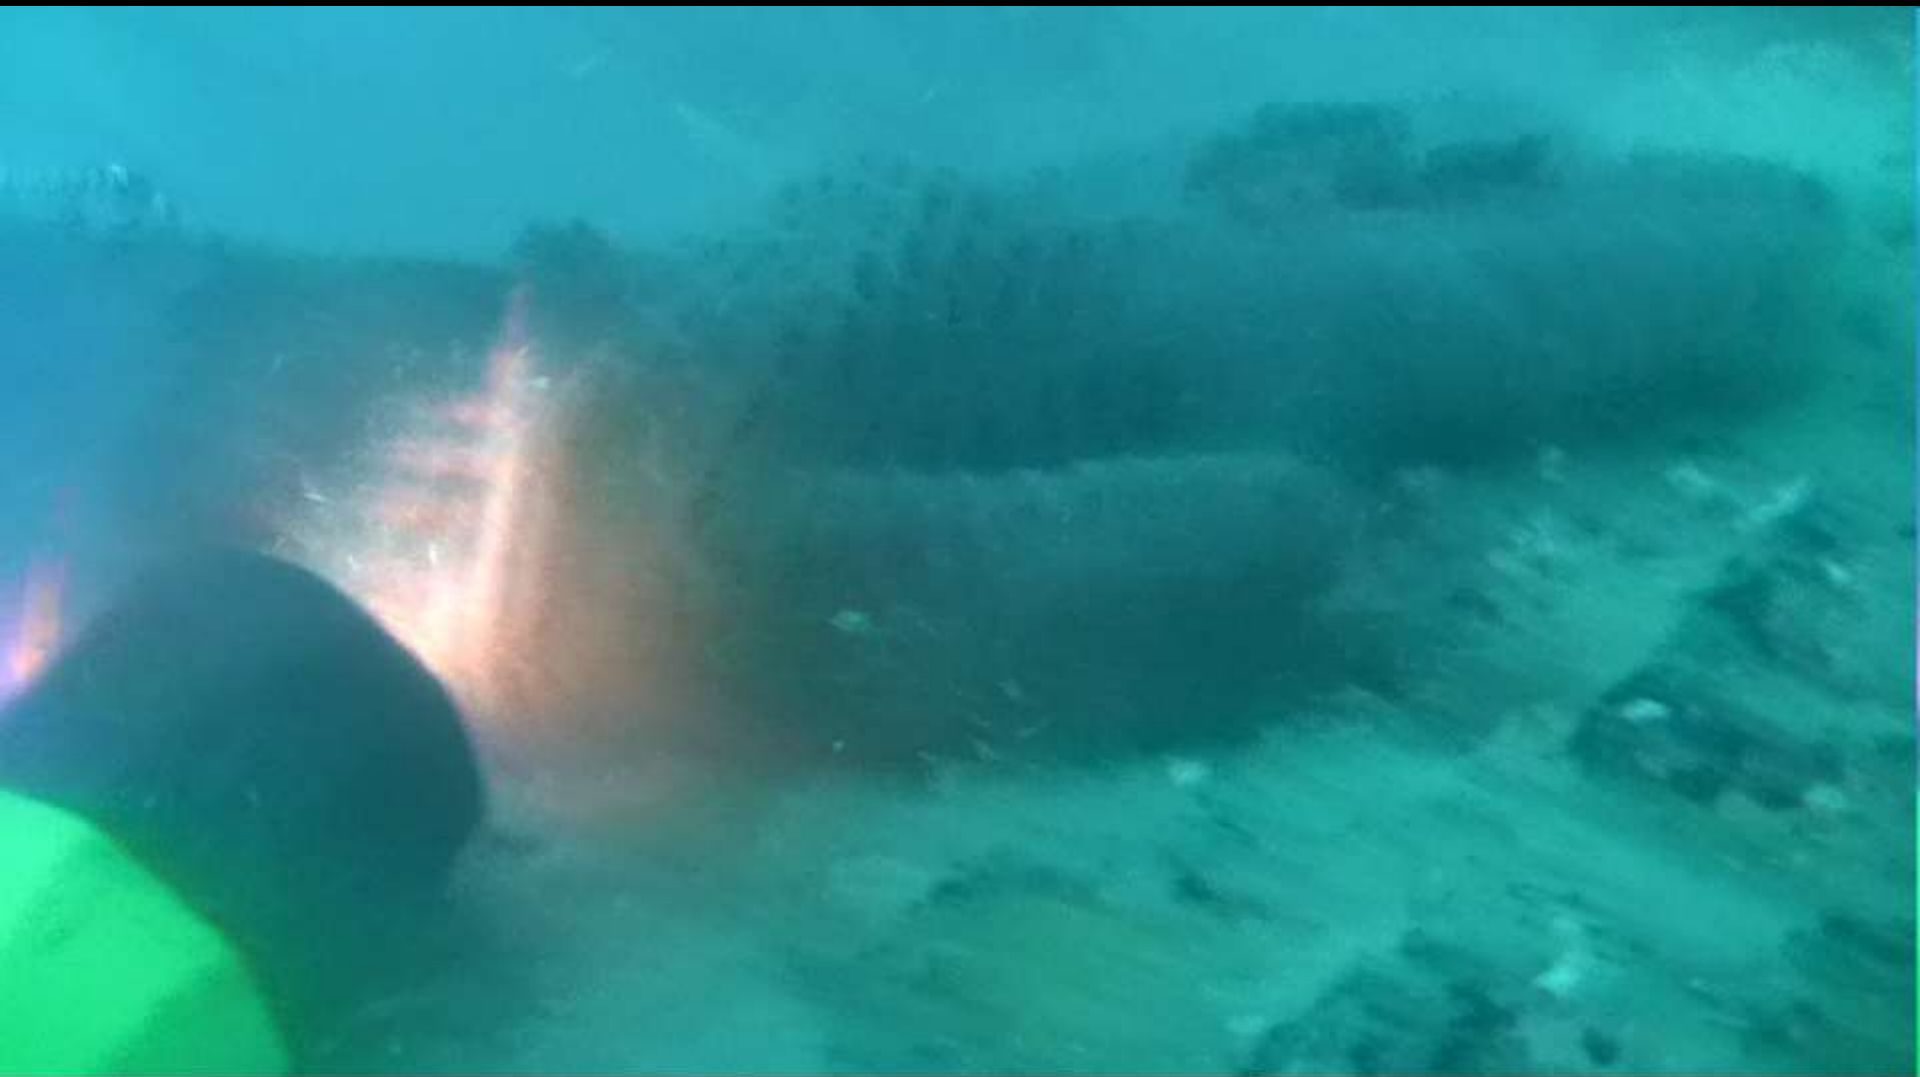
Starboard Tyre (Wheels Retracted)

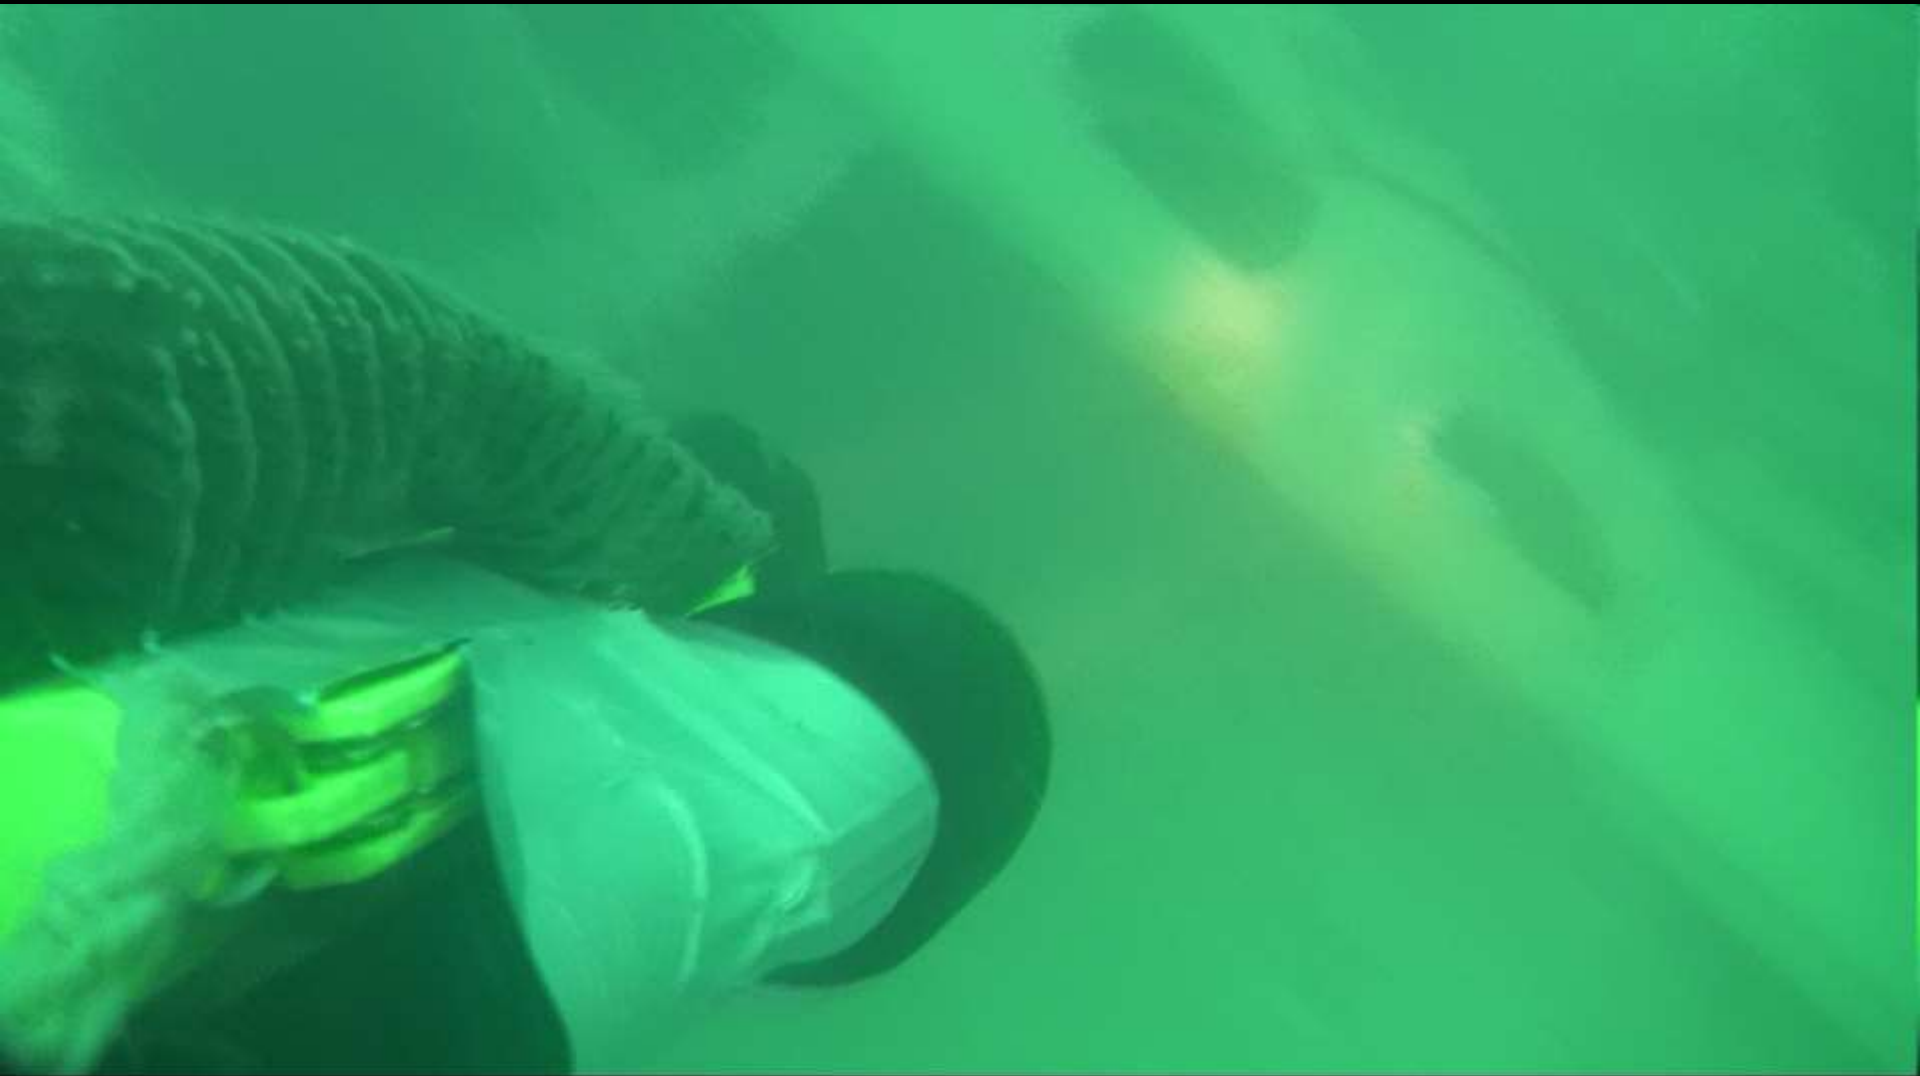
Horizontal Stabiliser (Tailplane) Elevator

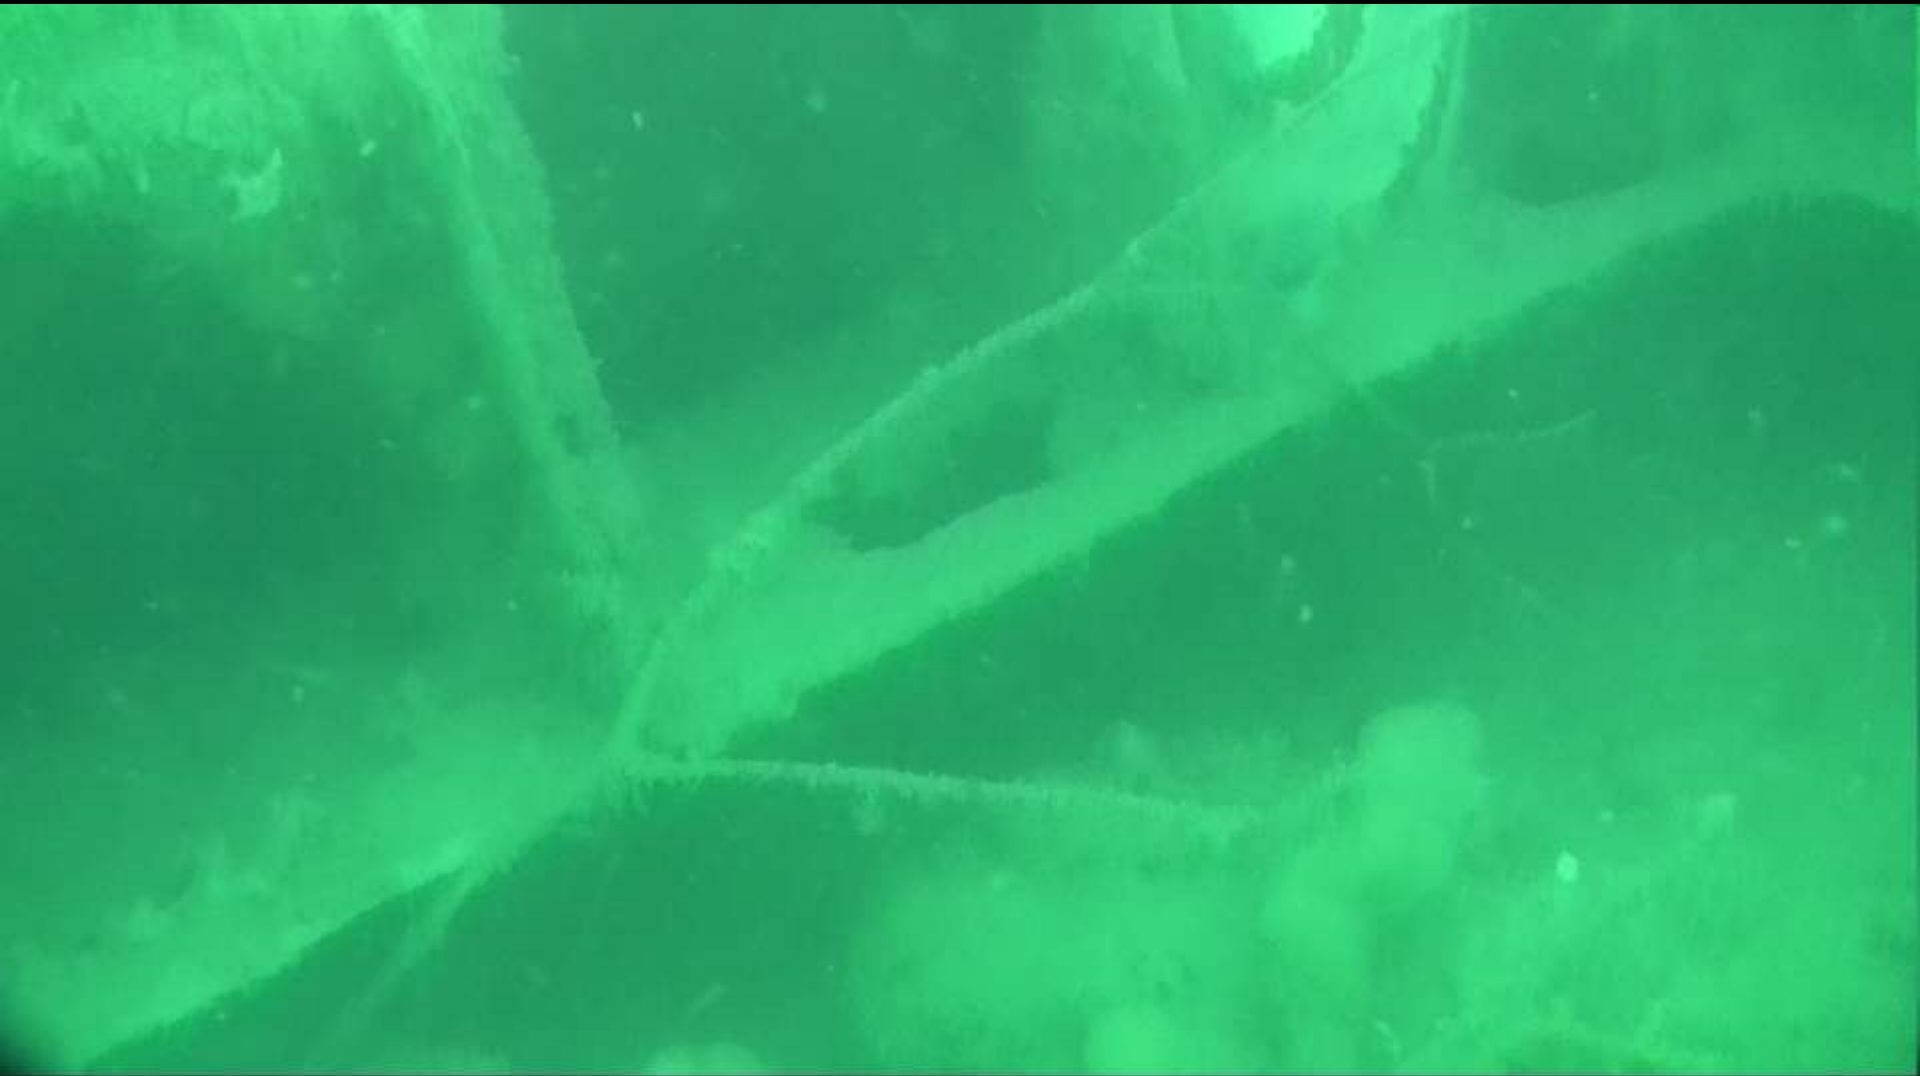
Horizontal Stabiliser Rear Edge (Elevator missing)
