B24 Liberator A72-80 Underwater Dive Inspection Truscott WA Discovered 17-18 Aug 2009

B-24 Liberator

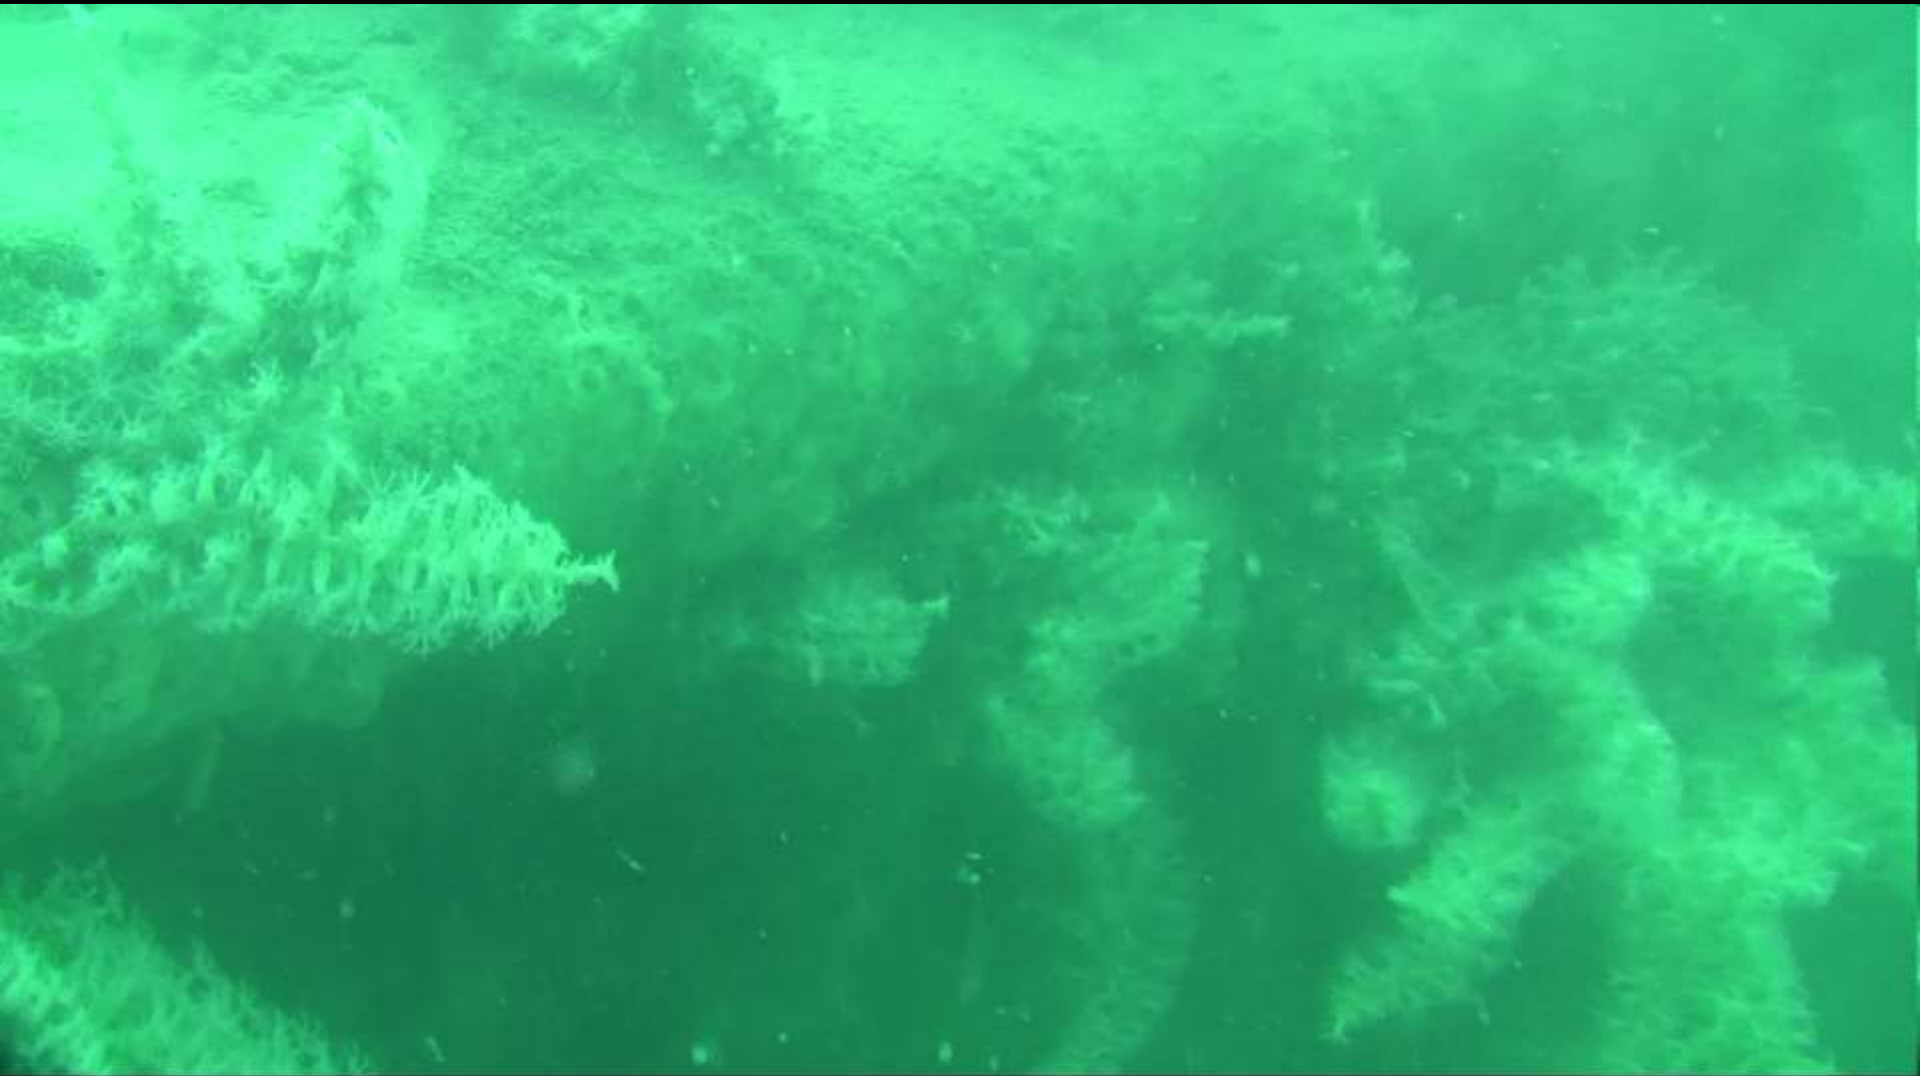
Horizontal Stabiliser Leading Edge

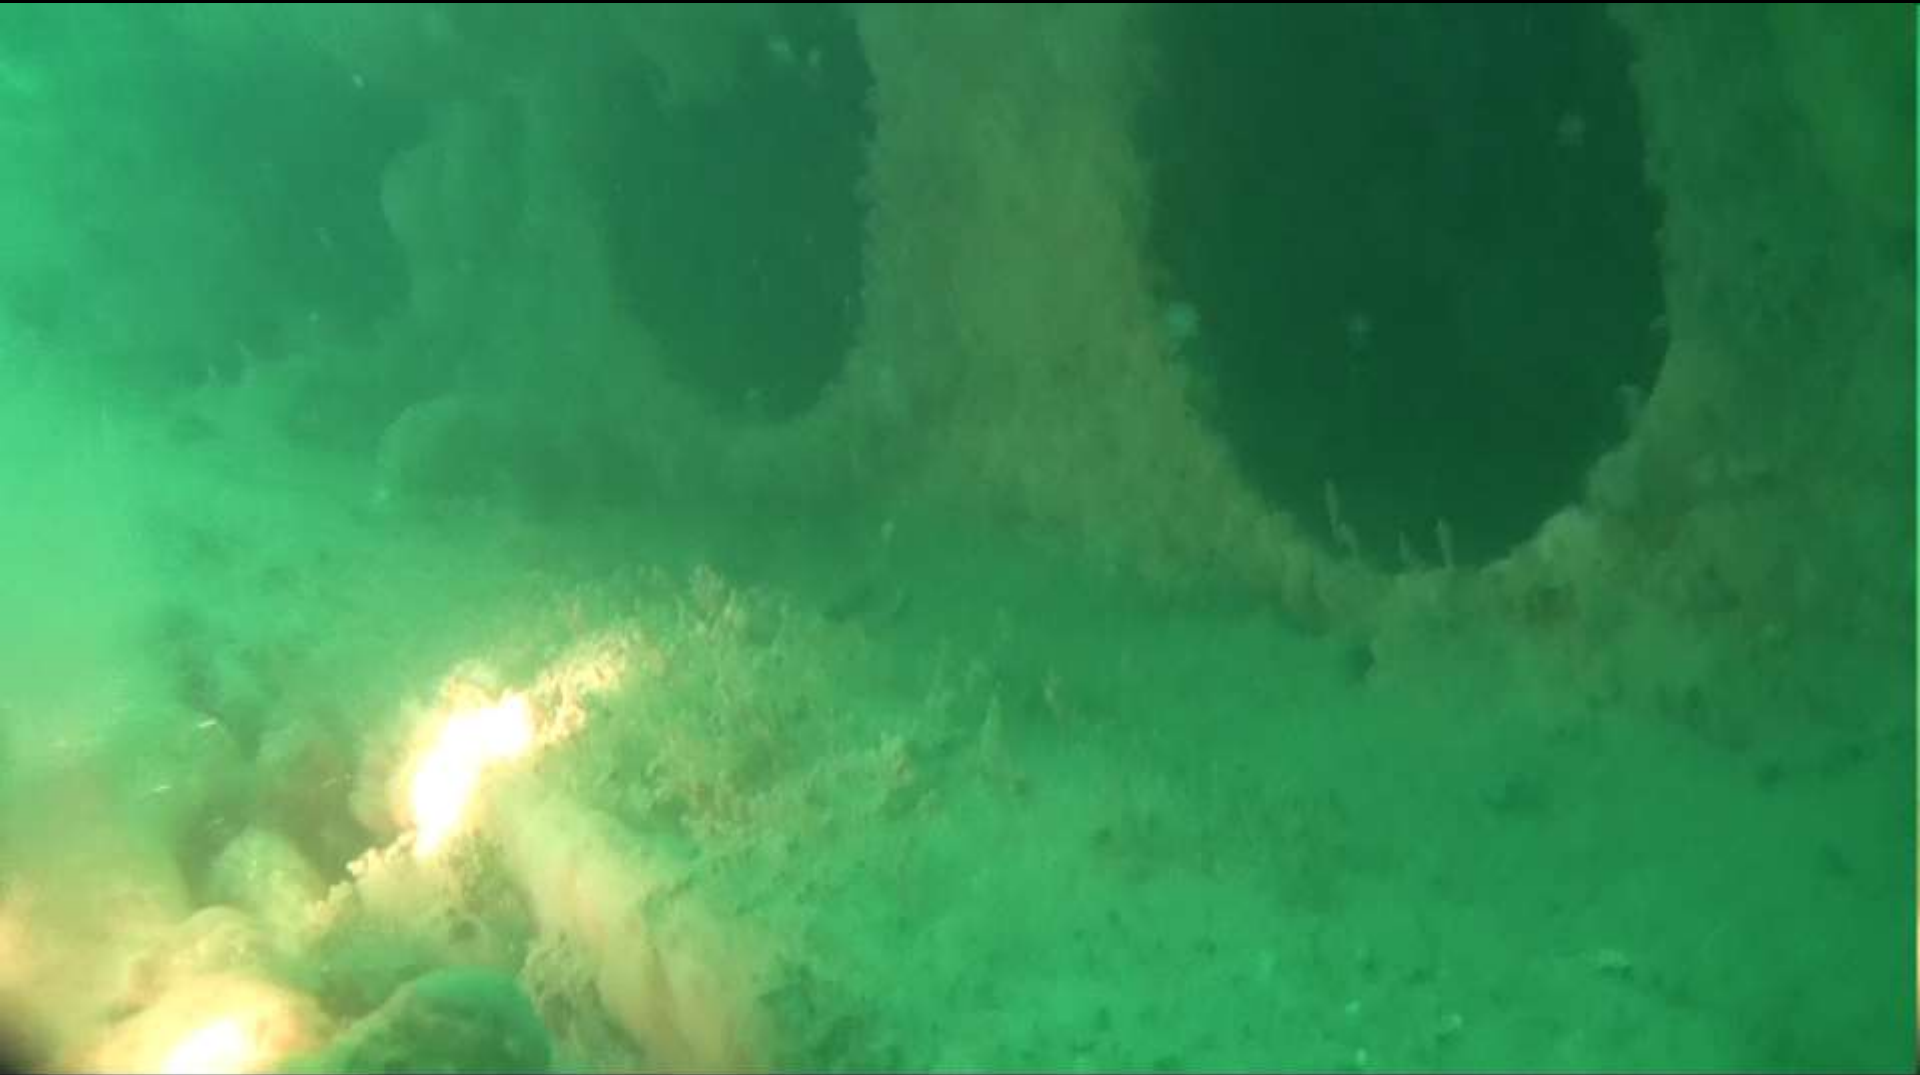
Horizontal Stabiliser; End section, Vertical fin Broken Off.

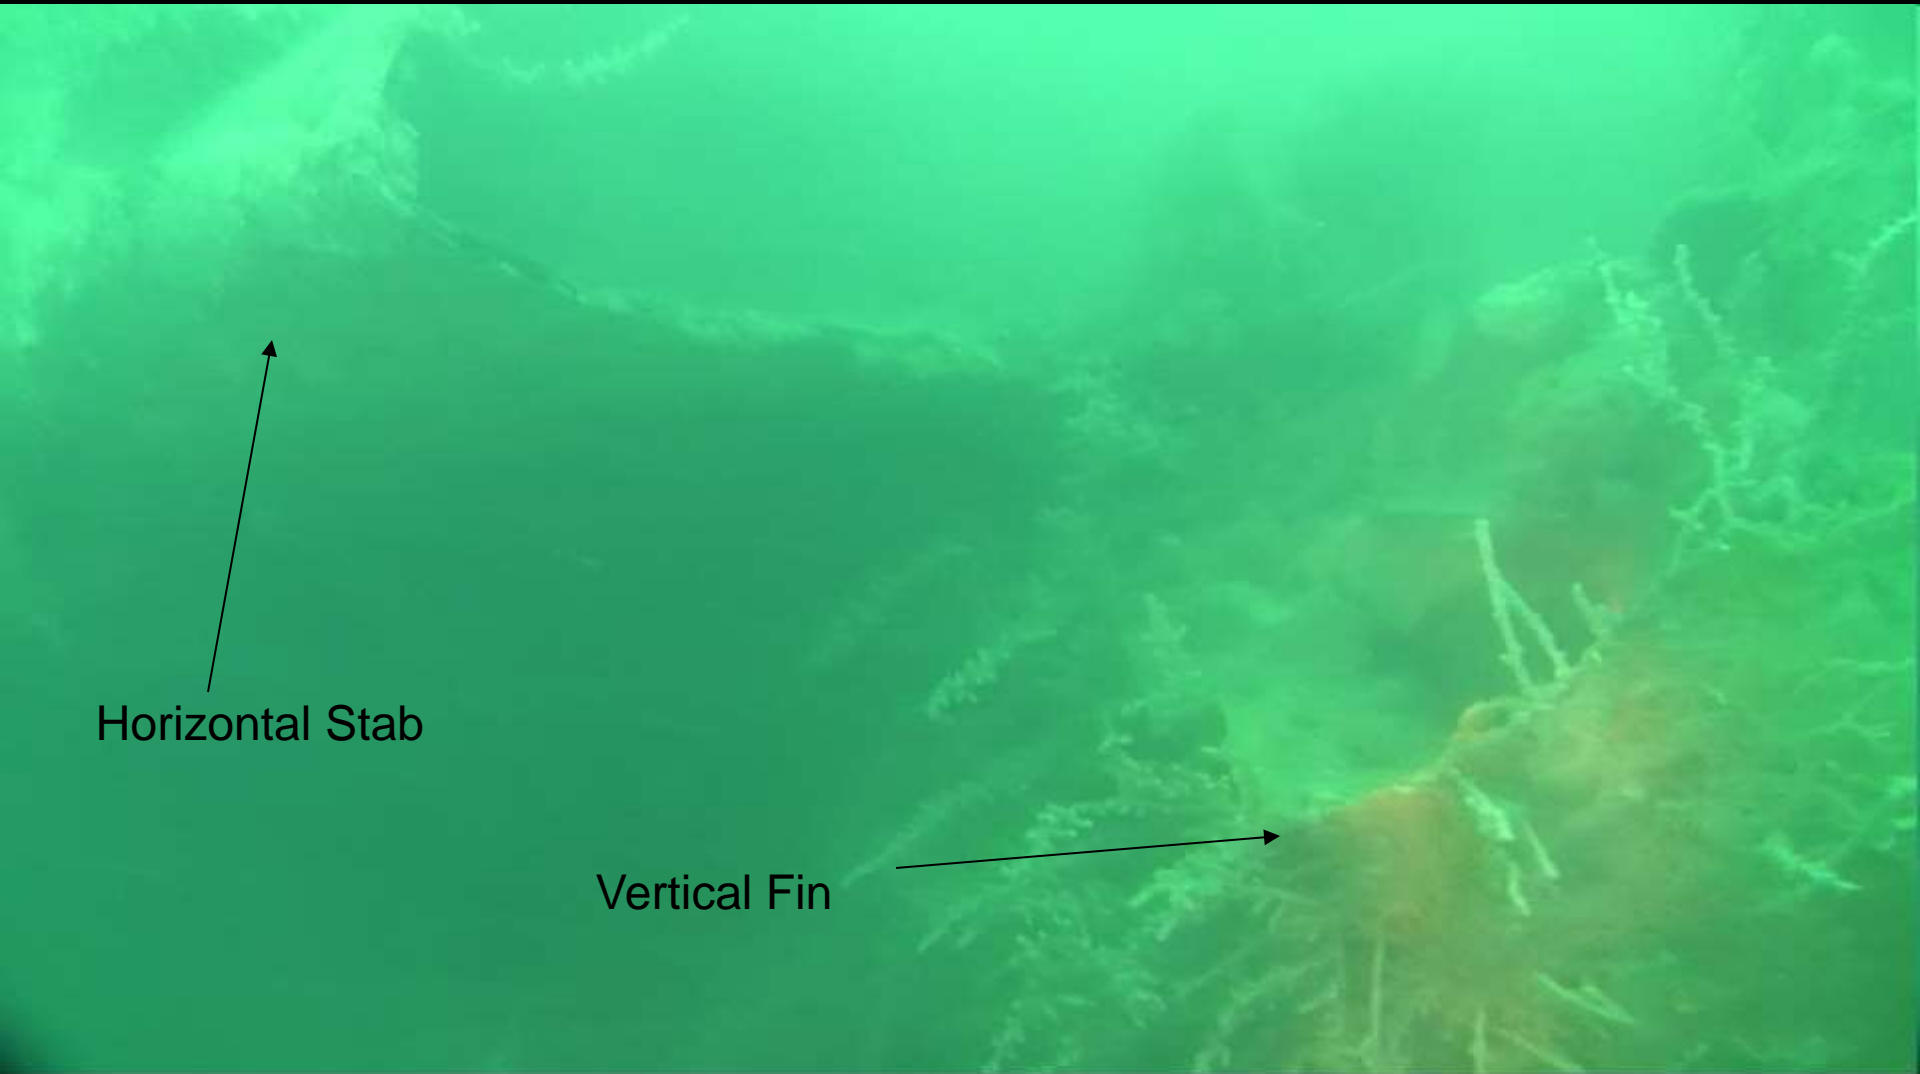
Horizontal Stabiliser; End section, Vertical fin Broken Off.
Airfoil Shape Suggests that Tail is Inverted

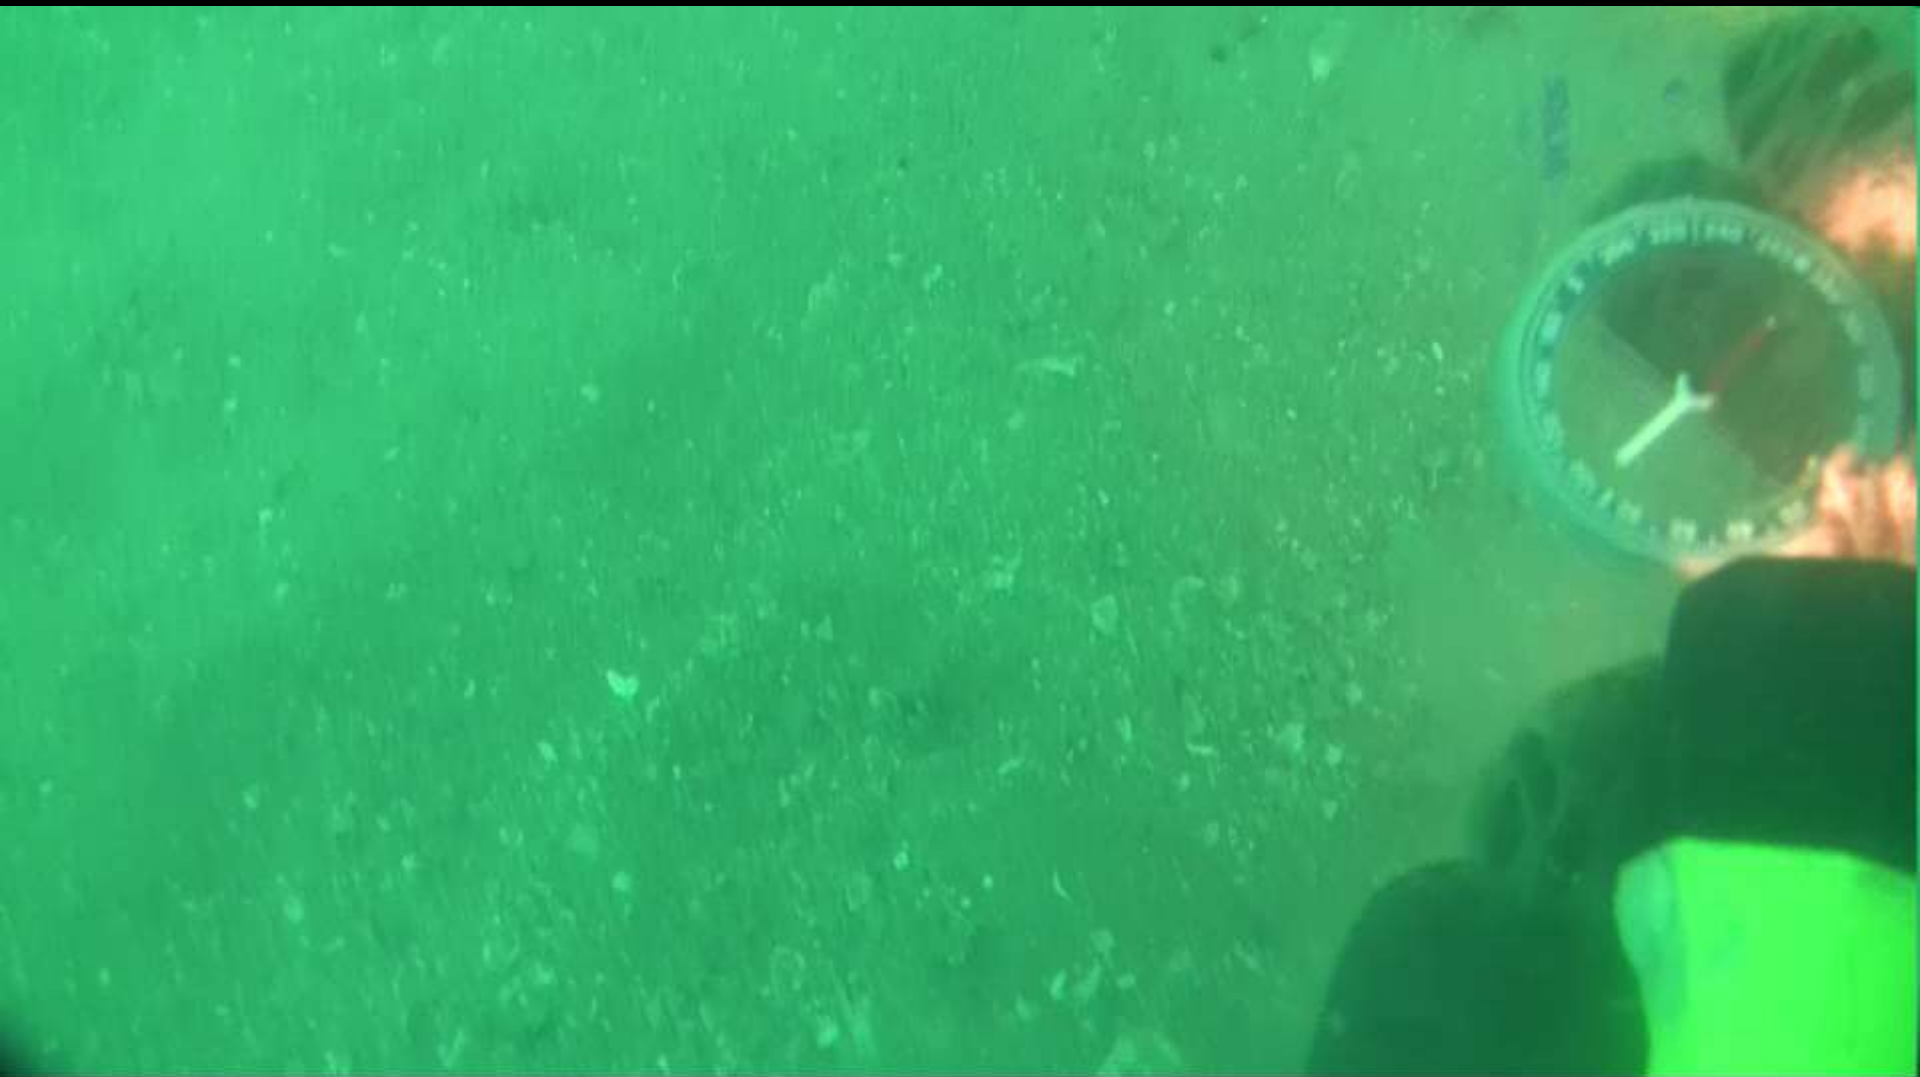
Swimming in Direction of Buried Fuselage from Horizontal Stab (NW)

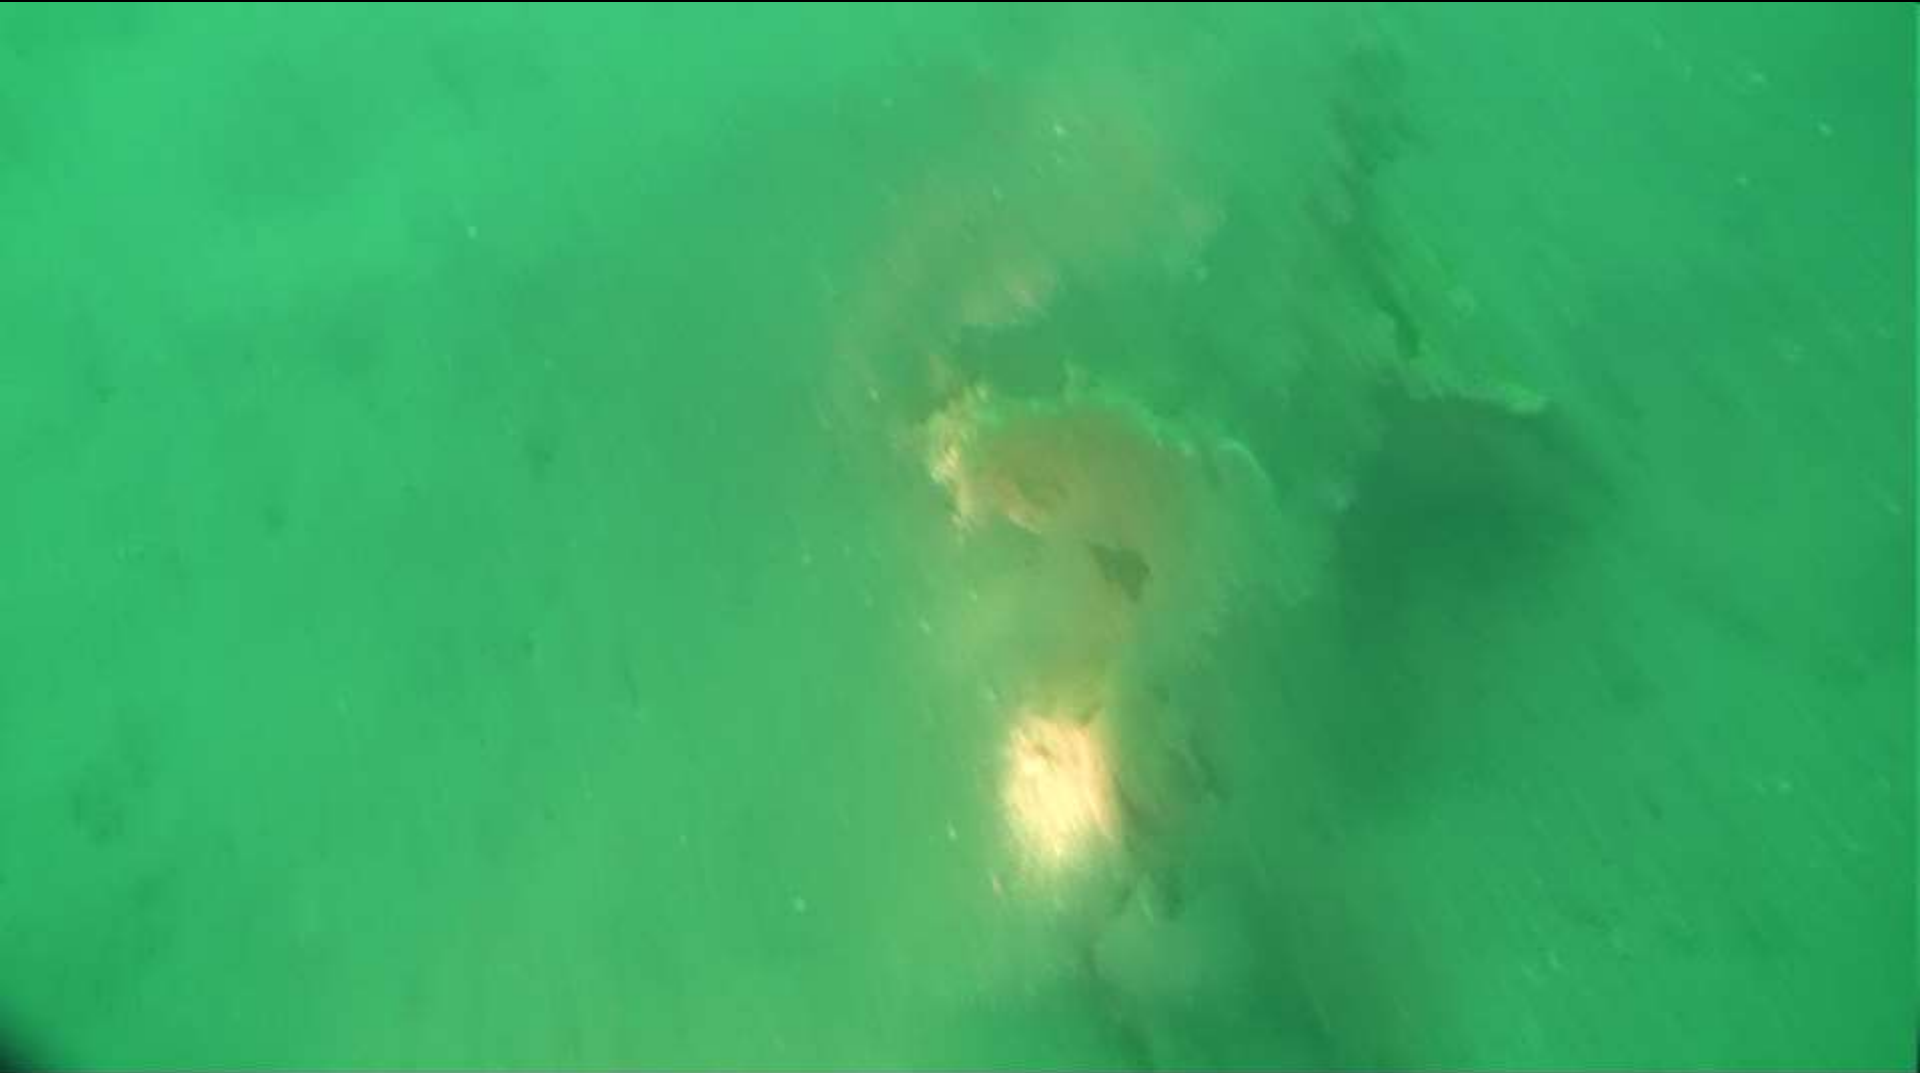
Piece of Metal protruding from Sand when Swimming NW from Stab'.
